Site Survey of Selected Items  
for  
Compliance with the Americans with Disabilities Act  
(ADAAG)  
and  
Title 24 of the CBC

The site survey of Ellen Ochoa Learning Center was conducted on February 27, 2007 during a spot check for compliance with the Americans with Disabilities Act Guidelines (ADAAG) and Title 24 of the CBC

# Facility Name: Ellen Ochoa Learning Center

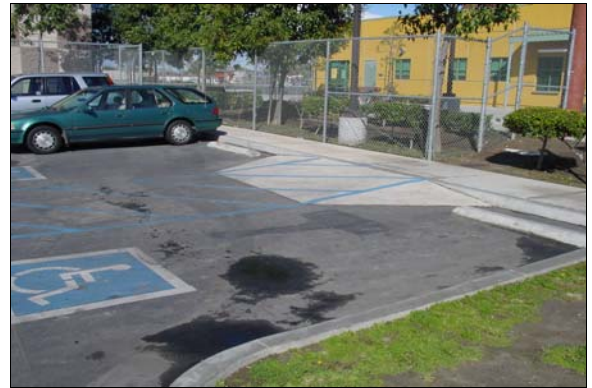
Accessible Parking

**Finding:** There are two accessible parking spaces in the parking lot off of Florence Avenue. There is no van-accessible space, the shared access aisle is not 96 inches wide, and the right space is not outlined on the right side. The access aisle does not contain "NO PARKING" in 12" high white letters.

**Full Rec** Restripe the designated accessible parking spaces to create one van-accessible and one standard accessible parking space, each measuring at least 108 inches wide and 216 inches long with an access aisle measuring at least 96 inches wide (8 feet) shared between the two accessible parking spaces (see CBC 1129B). The accessible parking space with the access aisle to the right of the space shall be designated "van-accessible." Add the words NO PARKING in 12 inch high white letters at the entrance to each accessible parking access aisle.

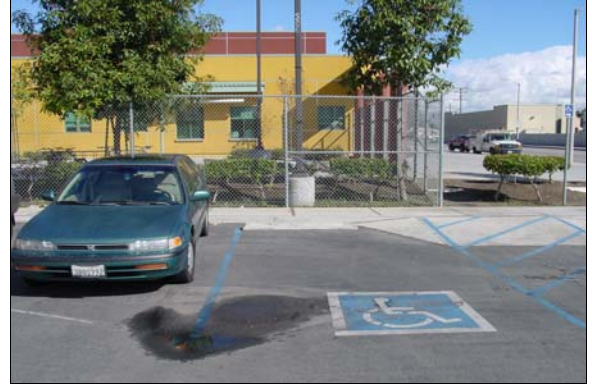
Accessible Parking

**Finding:** There is no post-mounted sign showing the International Symbol of Accessibility at the head of each parking space.

**Full Rec** Install a permanently posted reflectorized sign measuring 70 square inches that includes an ISA symbol adjacent to and visible from each accessible parking space (see CBC 1129B.5). The bottom edge of each sign must be mounted 80 inches from the ground surface so that it cannot be obscured by a parked vehicle (see CBC 1129B.5). The "van-accessible" parking space shall provide an additional sign marked "van-accessible" mounted below the sign (see CBC 1129B.5 and ADAAG 4.6.4).

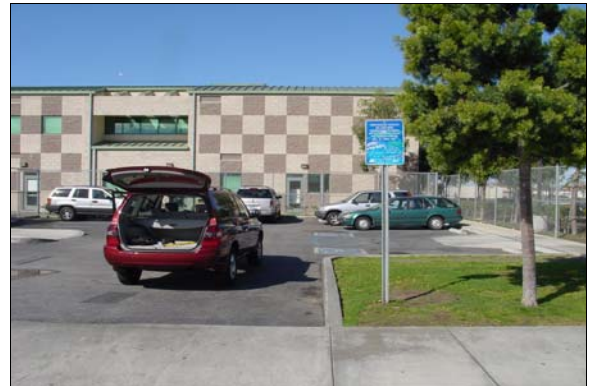
Accessible Parking

**Finding:** There is warning signage posted at the entrance from Florence Avenue regarding unauthorized use of accessible parking spaces in the parking lot. The lettering on the sign has been vandalized. The sign does not contain the California Vehicle Code.

**Full Rec** Fill in the blank spaces which are required to furnish the point of contact and telephone number for reclaiming towed vehicles with the appropriate information as a permanent part of the sign and maintain the currency of the information (see CBC 1129B.5). Make sure to add the CVC22511.8(a)(d) to the sign.

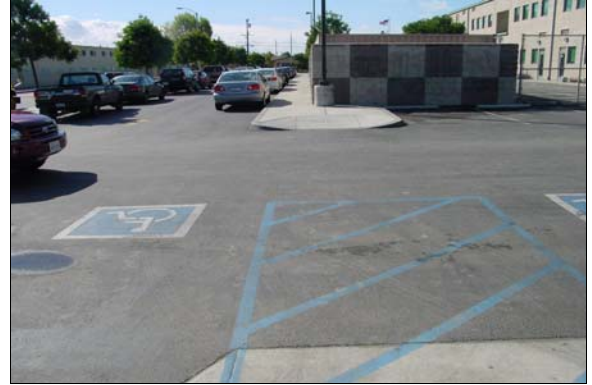
Accessible Parking

**Finding:** There is no crosswalk provided on the path of travel from the accessible parking space to the facility. The required accessible route crosses a vehicular way.

**Full Rec** Stripe a crosswalk not less than 48 inches wide on the path of travel to the accessible entrance. Provide a level surface that does not exceed a slope greater than 5%. Cross slopes shall not exceed 2%. Detectable warnings should be placed at the entrance and exit of the crosswalk.

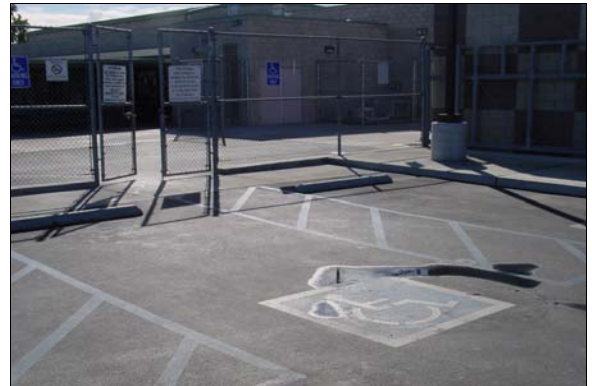
Accessible Parking next to the MPR

**Finding:** There are three accessible parking spaces located next to the MPR. The far right space is not outlined on the right side and each access aisle does not contain "NO PARKING" in 12" high white letters.

**Full Rec** Restripe the existing far right space on the right side and add the words NO PARKING in 12 inch high white letters at the entrance to each accessible parking access aisle.

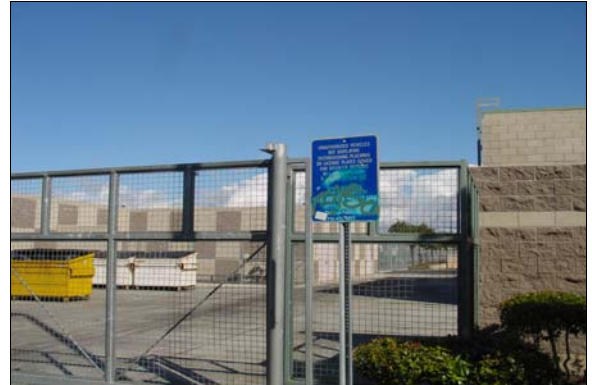
Accessible Parking next to the MPR

**Finding:** There is warning signage posted at the entrance from Live Oak regarding unauthorized use of accessible parking spaces in the parking lot. The lettering on the sign has been vandalized and the California Vehicle Code is not present.

**Full Rec** Fill in the blank spaces which are required to furnish the point of contact and telephone number for reclaiming towed vehicles with the appropriate information as a permanent part of the sign and maintain the currency of the information (see CBC 1129B.5). Make sure to add the CVC22511.8(a)(d) to the sign.

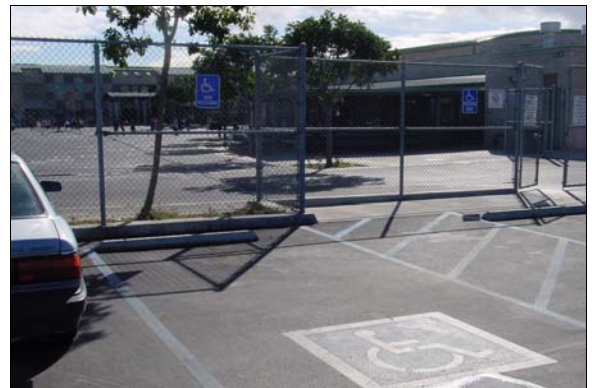
Parking next to the MPR

**Finding:** At the entrance to each access aisle the pedestrian and vehicular route is level and not separated by a ramp, curb or other element . There are no detectable warning stripes affixed to the entrance of each access aisle.

**Full Rec** Affix detectable warning stripes to the entrance and exit of each access aisle.

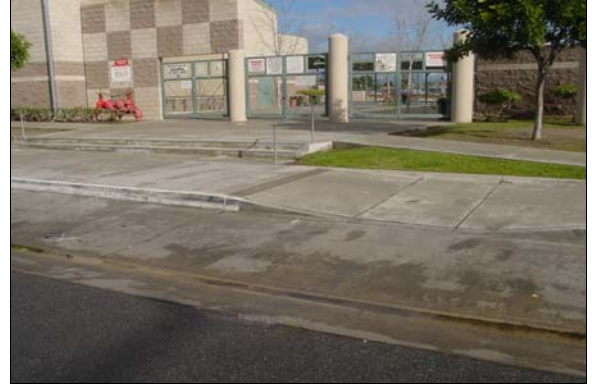
Bus Loading Zone in front of the School

**Finding:** There is no required striped access aisle adjacent to the passenger loading zone on Live Oak Street. There is no signage designating accessibility posted at the passenger loading zone.

**Full Rec** Stripe an access aisle at least 5 feet (60 inches) wide and 20 feet (240 inches) long adjacent and parallel to the vehicle pull-up space. The access aisle striping for the passenger loading zone shall provide immediate access to the adjacent curb ramp. Post signage designating the passenger loading zone as accessible (see CBC 1131B and ADAAG 4.1.2(7)(b)). The sign should contain the International Symbol of Accessibility.

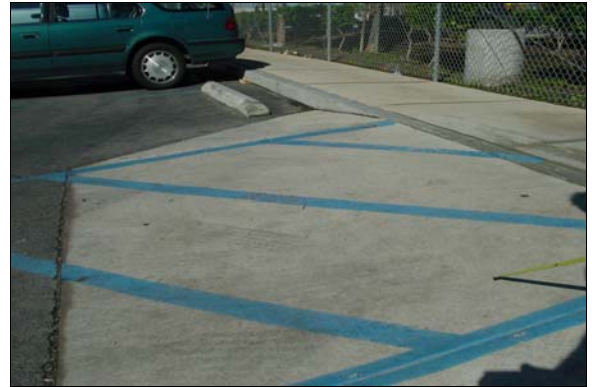
Curb Ramp at the Access Aisle

**Finding:** The built-up curb ramp projects into vehicular traffic and access aisle and interferes with individuals entering or exiting parked or standing vehicles. The curb ramp does not have a detectable warning surface of truncated domes.

**Full Rec** Provide a compliant curb ramp at the access aisle.

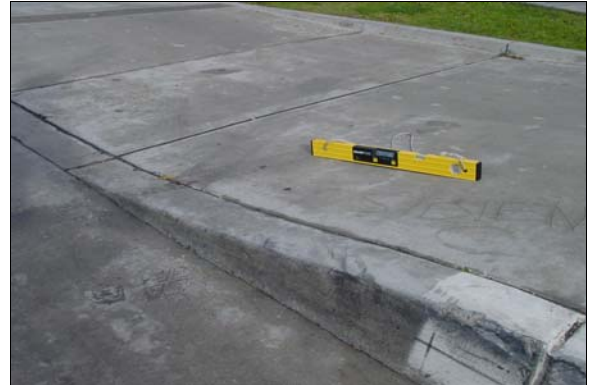
Curb Ramp at the Bus Loading Zone

**Finding:** The slope of the top and bottom landing is greater than 2%. The slope of the side flares is greater than 10%. There is no detectable warning surface of truncated domes.

**Full Rec** Replace the concrete curb-cut ramp with a concrete curb-cut ramp at least 48 inches in width that provides a slope no greater than 8.33% and a cross slope no greater than 2%. The slope of the top landing shall not exceed 2% and shall provide at least 48 inches in length of maneuvering clearance. The bottom landing shall provide a smooth transition. The side flares shall be no greater in slope than 10%. Provide a compliant 36 inch strip of truncated domes on the curb ramp.

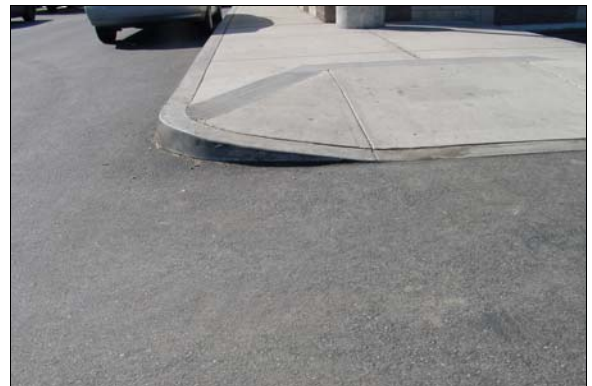
Curb Ramp at the Florence Avenue Parking Lot

**Finding:** The slope of the side flares is greater than 10%. There is no detectable warning surface of truncated domes.

**Full Rec** Replace the concrete curb-cut ramp with a concrete curb-cut ramp at least 48 inches in width that provides a slope no greater than 8.33% and a cross slope no greater than 2%. The slope of the top landing shall not exceed 2% and shall provide at least 48 inches in length of maneuvering clearance. The bottom landing shall provide a smooth transition. The side flares shall be no greater in slope than 10%. Provide a compliant 36 inch strip of truncated domes.

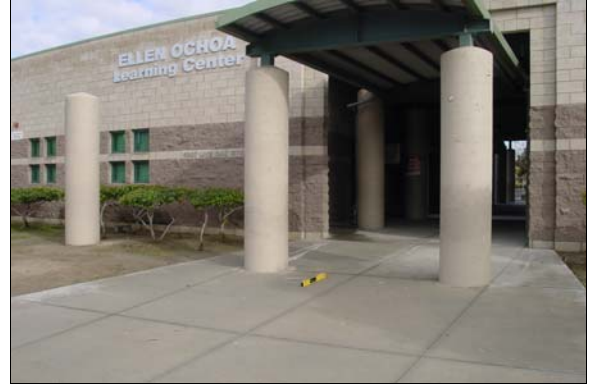
Sidewalk to the Main Entrance

**Finding:** The sidewalk from Live oak Street to the main entrance slopes greater than 5%.

**Full Rec** Resurface the path of travel to provide a level surface that does not exceed a slope greater than 5%. Cross slopes shall not exceed 2%. Otherwise the sidewalk qualifies as a ramp and will have to meet ramp compliant standards.

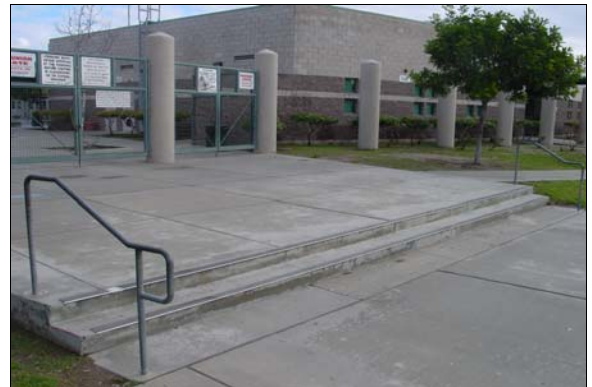
Exterior Stairs next to the Bus Loading Zone

**Finding:** The width of the stairway is greater than 88 inches and does not have a middle handrail.

**Full Rec** Provide one intermediate handrail for each 88 inches of stairway width. Space intermediate handrails equally across the entire width of the stairway.

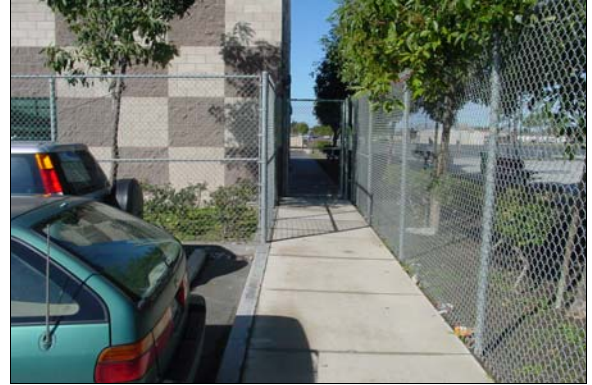
Gate from Florence Avenue Parking to School

**Finding:** The bottom 10 inches of the gate does not provide a smooth, uninterrupted surface, or panel to allow the door to be opened by a wheelchair footrest without creating a trap or hazardous condition.

**Full Rec** Install a panel or replace the gate to provide a smooth, uninterrupted surface for the bottom 10 inches of the door.

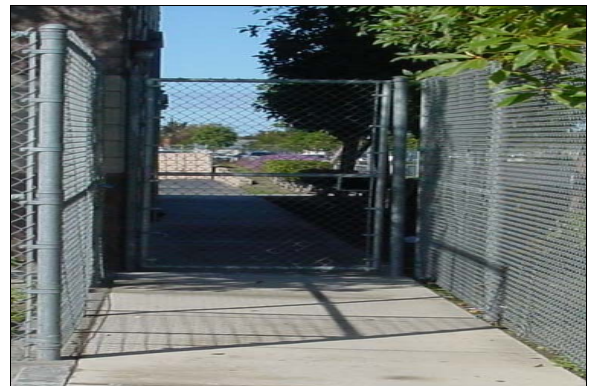
Gate from Florence Avenue Parking to School

**Finding:** The hardware on the gate is not accessible.

**Full Rec** Replace the existing gate hardware with accessible hardware (see ADAAG 4.13.9).

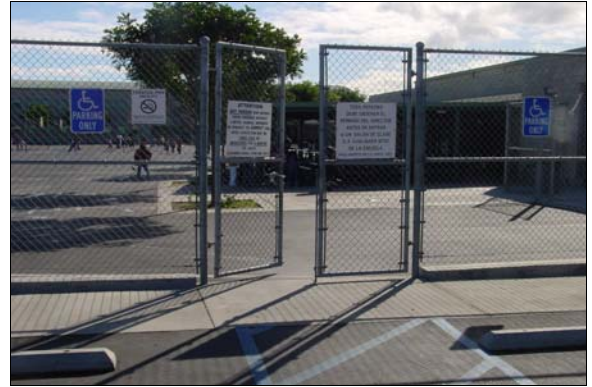
Gate from MPR Parking Lot to School

**Finding:** The bottom 10 inches of the gate does not provide a smooth, uninterrupted surface, or panel to allow the door to be opened by a wheelchair footrest without creating a trap or hazardous condition.

**Full Rec** Install a panel or replace the gate to provide a smooth, uninterrupted surface for the bottom 10 inches of the door.

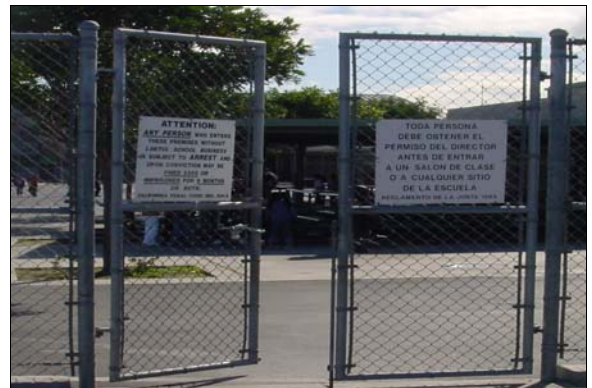
Gate from MPR Parking Lot to School

**Finding:** The hardware on the gate is not accessible.

**Full Rec** Replace the existing gate hardware with accessible hardware (see ADAAG 4.13.9).

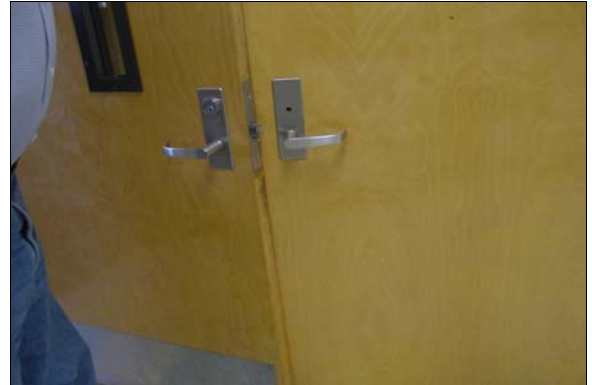
Nurses Office

**Finding:** There is less than 48 inches of clearance between the entrance door to the nurses office and the unisex restroom door in the nurses office.

**Full Rec** Reverse the entrance door swing or provide at least 48 inches of clear space between doors in a series.

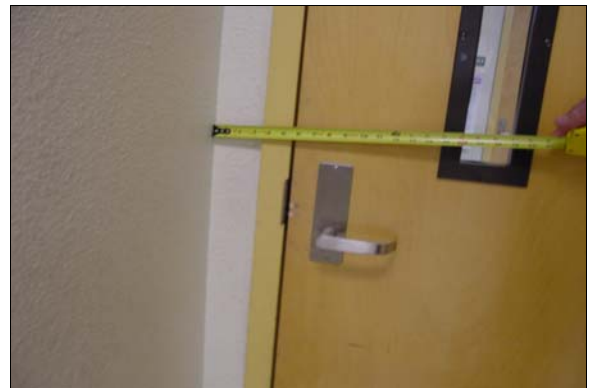
Nurses Office

**Finding:** There is less than 18 inches of latch side clearance from the pull side of the interior entrance door to the nurses office.

**Full Rec** Provide at least 18 inches of latch side clearance at the entrance door from the pull side (see ADAAG 4.13.6 and Figure 25).

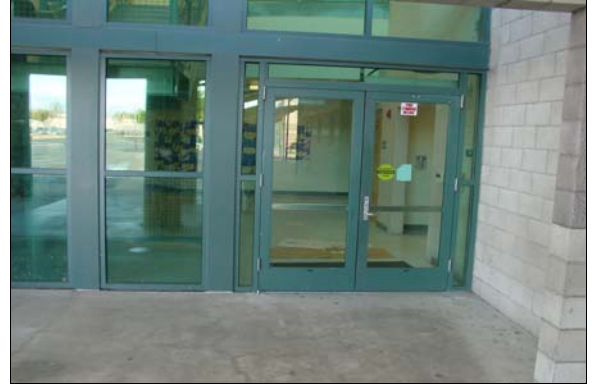
Directional Signage

**Finding:** There is no directional signage to the classrooms or other common use areas.

**Full Rec** Install directional signage to each common area complying with CBC 1117B.5 and ADAAG 4.30.

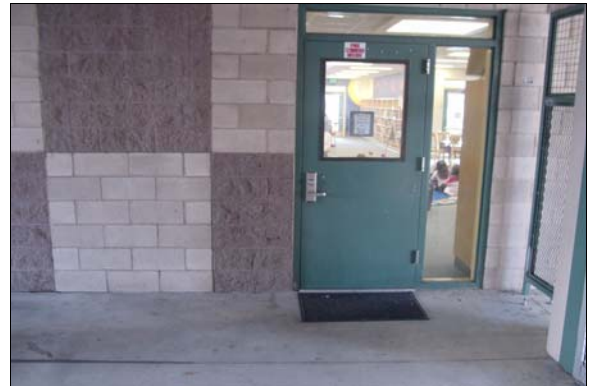
Library

**Finding:** The library does not have accessible signage mounted on the wall adjacent to the latch side of the door.

**Full Rec** Install signage centered at 60 inches above the finished floor on the wall adjacent to the latch side of each entry doorway stating "ROOM" with raised UPPERCASE letters between 5/8 inch and 2 inches in height and Grade 2 Braille characters. The sign shall comply with the finish and contrast requirements set forth in CBC 1117B.5 and ADAAG 4.30.5. Signage should be located where a person may approach within three inches of the sign without encountering protruding objects or standing within the swing of the door.

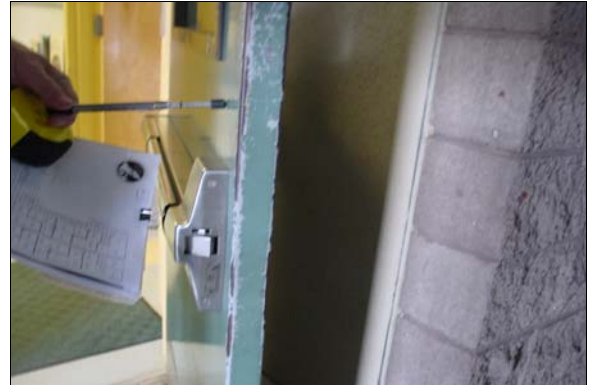
Main Entrance to the Office

**Finding:** The main entrance does not have accessible signage mounted on the wall adjacent to the latch side of the door.

**Full Rec** Install signage centered at 60 inches above the finished floor on the wall adjacent to the latch side of the entry doorway stating ENTRANCE from the outside and EXIT from the inside, with raised UPPERCASE letters between 5/8 inch and 2 inches in height and Grade 2 Braille characters. The sign shall comply with the finish and contrast requirements set forth in CBC 1117B.5 and ADAAG 4.30.5. Signage should be located where a person may approach within three inches of the sign without encountering protruding objects or standing within the swing of the door.
