Site Survey of Selected Items
for
Compliance with the Americans with Disabilities Act
(ADAAG)
and
Title 24 of the CBC

The site survey of Miguel Contreras Learning Complex was conducted on February 26, 2007 during a spot check for compliance with the Americans with Disabilities Act Guidelines (ADAAG) and Title 24 of the CBC

Facility Name: Miguel Contreras Learning Complex

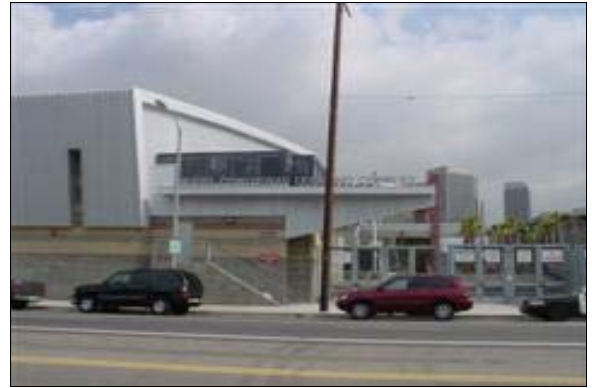
Finding: Miguel Contreras Learning Complex located at 322 Lucas Avenue in Los Angeles California, provides services to students in Grades 9 thru 12. The facility was inspected by Disability Access Consultants, Inc., on February 26, 2007. This is a report of selected items and is not intended as a full report.

Full Rec Any renovation or new construction that occurred after January 26, 1992, is subject to meet full code specifications for the California Building Code and ADAAG requirements. All recommendations in this report are based on ADAAG and CBC title 24 requirements. Consult with your design professional to determine which elements are affected by these requirements. It is recommended that Disability Access Consultants, Inc. is consulted for inspection of any new construction or renovation at the facility.

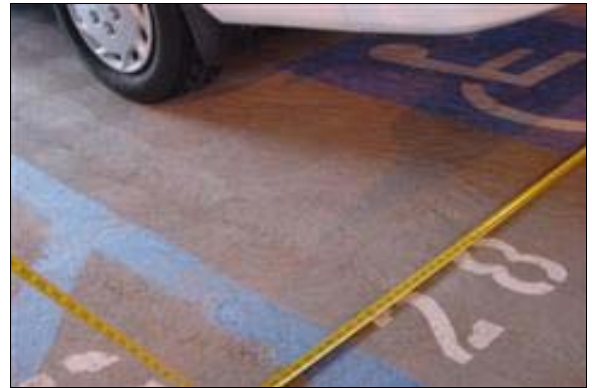
Accessible Parking

Finding: There are five accessible parking spaces which is sufficient in number as required for compliance. Each accessible parking space provided measures less than 108 inches wide. The "van-accessible" access aisle measures 91 inches wide.

Full Rec Restripe the designated accessible parking spaces to create one van-accessible and standard accessible parking spaces, each measuring at least 108 inches wide and 216 inches long. Designate one parking space as "van-accessible". The van-accessible space shall provide an access aisle measuring at least 96 inches wide on the passenger side (right side) of the vehicle space. The additional parking spaces shall each provide an access aisle measuring at least 60 inches wide, that may be shared. Add the words NO PARKING in 12 inch high white letters at the entrance to each accessible parking access aisle.

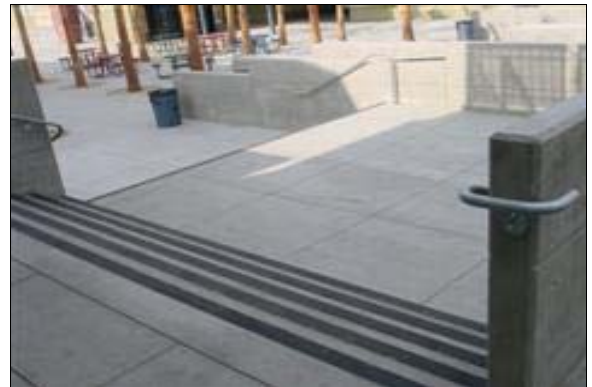
Stairs at Building 3

Finding: The width of the stairway is greater than 88 inches.

Full Rec Provide one intermediate handrail for each 88 inches of stairway width. Space intermediate handrails equally across the entire width of the stairway.

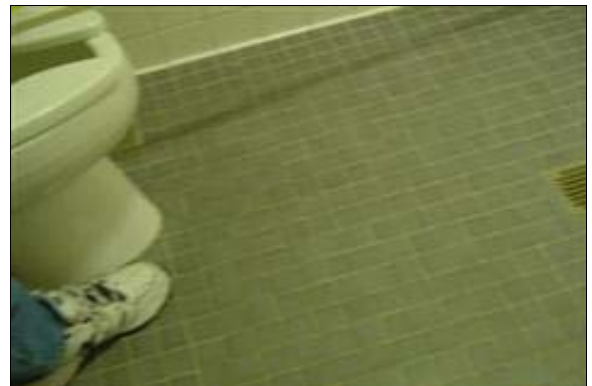
Unisex Staff Restroom in Office

Finding: This restroom is not accessible and cannot be easily altered. There is not sufficient clear floor space in the restroom. The inward swing of the entrance door reduces the clear floor space in the restroom.

Full Rec Consult a design professional to modify the restroom. One or more walls may need to be moved to provide sufficient clear floor space to inscribe a 60-inch diameter turning radius in the restroom. The door swing may be reversed to provide greater clear floor space in the restroom.

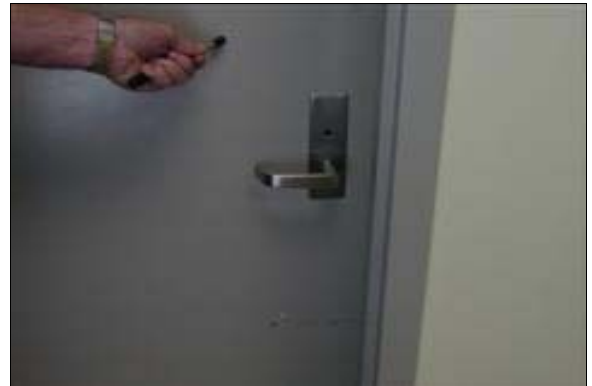
Womens Restroom at Rear of Stage

Finding: The door opening force for the interior entrance door to the restroom is greater than 5 pounds.

Full Rec Adjust the closer on the interior entrance door to the restroom to a maximum door opening force of 5 pounds (see CBC 1133B.2.5.1 and ADAAG 4.13.11).

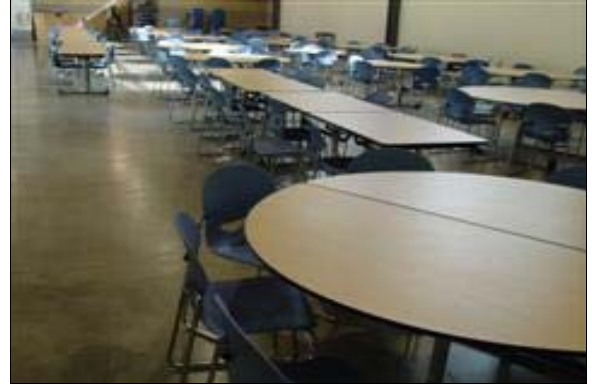
Cafeteria

Finding: There are no designated wheelchair seating spaces provided.

Full Rec Provide an ISA symbol designating at least 5% of each type of seating provided in the dining area as accessible. Accessible tables shall provide knee clearance of at least 27 inches in height, 30 inches in width and 19 inches in depth (see CBC 1122B.3, ADAAG 4.32.2 and ADAAG Figure 45). The table top height shall not exceed 34 inches above the finished floor. At least one companion fixed seat complying with ADAAG 4.33.3 should be provided next to each wheelchair seating space. An accessible route shall lead to and through each accessible seating area.

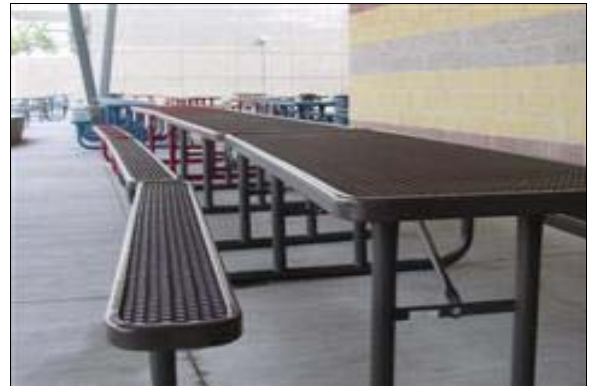
Outdoor Dining Area

Finding: There are no designated wheelchair seating spaces provided. The tables in the outdoor dining area are not accessible by design.

Full Rec Provide an ISA symbol designating at least 5% of each type of seating provided in the dining area as accessible. Accessible tables shall provide knee clearance of at least 27 inches in height, 30 inches in width and 19 inches in depth (see CBC 1122B.3, ADAAG 4.32.2 and ADAAG Figure 45). The table top height shall not exceed 34 inches above the finished floor. At least one companion fixed seat complying with ADAAG 4.33.3 should be provided next to each wheelchair seating space. An accessible route shall lead to and through each accessible seating area.
