Site Survey of Selected Items
for
Compliance with the Americans with Disabilities Act
(ADAAG)
and
Title 24 of the CBC

The site survey of William Howard Taft High School was conducted on February 26, 2007 during a spot check for compliance with the Americans with Disabilities Act Guidelines (ADAAG) and Title 24 of the CBC

Facility Name: William Howard Taft High School

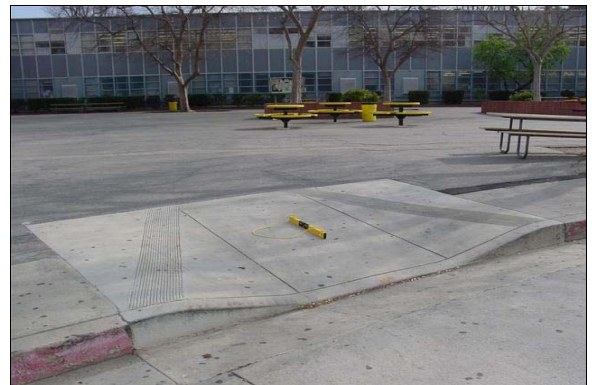
Curb Ramp at West Side of Building C at Service Road

Finding: The slope of the curb ramp is 10.3%. The slope at the top landing is 2.9%. The slope of the bottom landing is 11.7%. The slope of the side flares are greater than 10%. The transition at the bottom landing is abrupt. The curb ramp does not provide a detectable warning surface which includes truncated domes.

Full Rec Replace the curb ramp with a curb ramp at least 48 inches in width that provides a slope no greater than 8.33% and a cross slope no greater than 2%. The slope of the top landing shall not exceed 2% and shall provide at least 48 inches in length of maneuvering clearance. The bottom landing shall provide a smooth transition. The side flares shall be no greater in slope than 10%. Install a detectable warning surface which extends the full length and width of the concrete curb ramp and its side flares with truncated domes that contrast visually by either light on dark or dark on light which is an integral part of the concrete curb ramp.

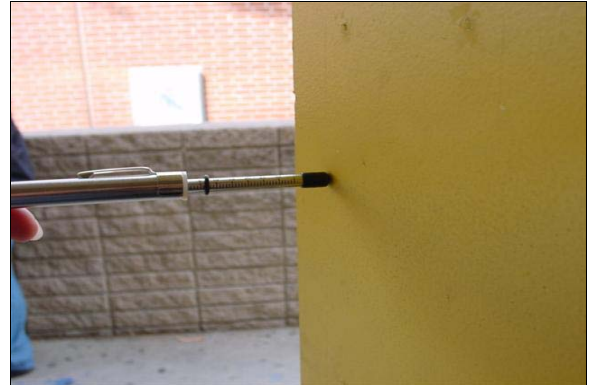
Boys Restroom Building M

Finding: The door opening force for the entrance door to the restroom is 6.5 pounds.

Full Rec Adjust the closer on the entrance door to the restroom to a maximum door opening force of 5 pounds.

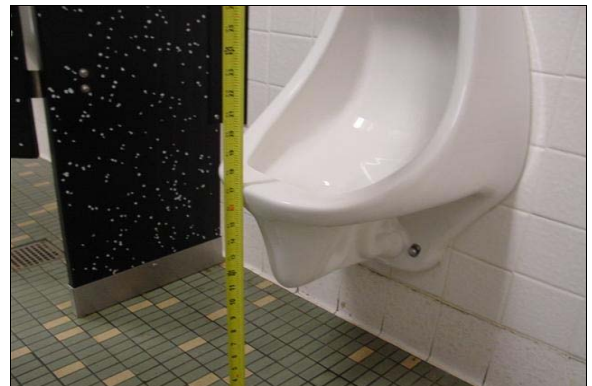
Boys Restroom Building M

Finding: The height of the urinal rim in the restroom is 17 1/4 inches above the finished floor.

Full Rec Lower the urinal designated to be accessible in the restroom so that the rim height is not more than 17 inches above the finished floor.

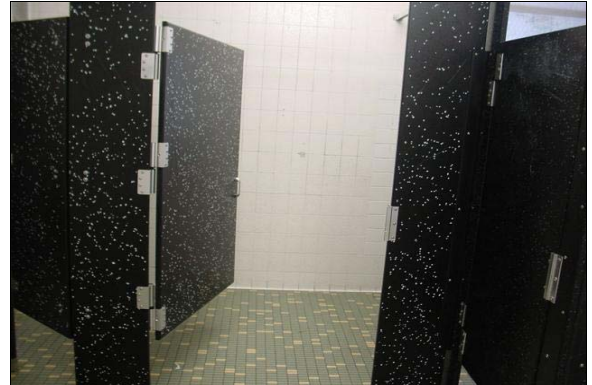
Boys Restroom Building M

Finding: The stall door to the stall designated to be accessible in the restroom swings inward limiting the clear floor space in the stall designated to be accessible.

Full Rec Modify the swing of the door on the stall designated to be accessible in the restroom so that it does not limit clear floor space in the stall.

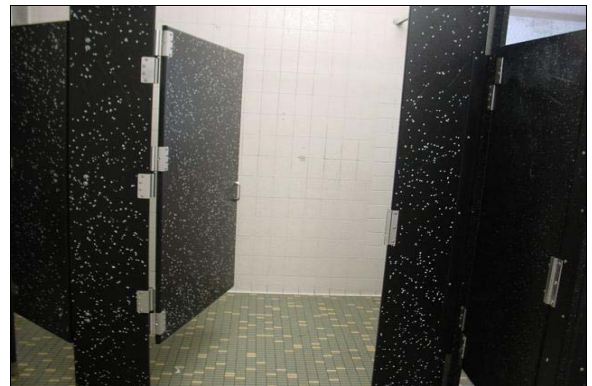
Boys Restroom Building M

Finding: The door to the stall designated to be accessible in the restroom does not close automatically or have accessible hardware.

Full Rec Provide an automatic door closer, spring hinge, pull bar or accessible handle mounted on the inside of the stall door to the stall designated to be accessible in the restroom (see ADAAG A4.17.5). Accessible hardware on the inside and outside of the stall designated to be accessible door shall be equipped with a loop or U-shaped handle mounted immediately below the latch. The latch shall be flip-over style, sliding or other hardware not requiring grasping or twisting. Make certain that the inside and outside door hardware is mounted no more than 48 inches above the finished floor (see CBC 115B.7.1.3 and ADAAG 4.13.9).
