Site Survey of Selected Items
for
Compliance with the Americans with Disabilities Act
(ADAAG)
and
Title 24 of the CBC

The site survey of Woodrow Wilson High School was conducted on
February 27, 2007 during a spot check for compliance with the
Americans with Disabilities Act Guidelines (ADAAG)
and
Title 24 of the CBC

Facility Name: Woodrow Wilson High School

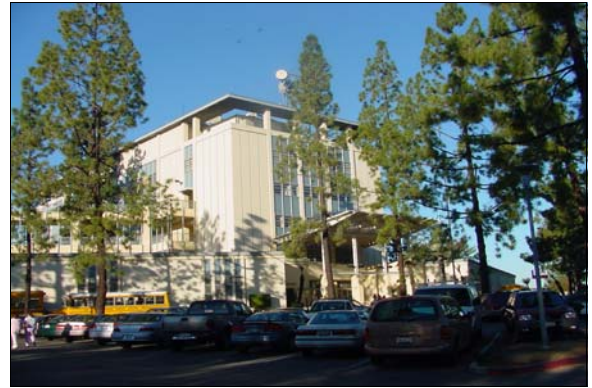
Finding: Woodrow Wilson High School is located at 4500 Multnomah Street Los Angeles California. The 1969 facility provide services to students in grades 9 thru 12 and was inspected by Disability Access Consultants, Inc., on February 28, 2007. This report is a report of selected items and is not intended as a full report.

Full Rec Any renovation or new construction that occurred after January 26, 1992, is subject to meet full code specifications for the California Building Code and ADAAG requirements. All recommendations in this report are based on ADAAG and CBC title 24 requirements. Consult with your design professional to determine which elements are affected by these requirements. It is recommended that Disability Access Consultants, Inc. is consulted for inspection of any new construction or renovation at the facility.

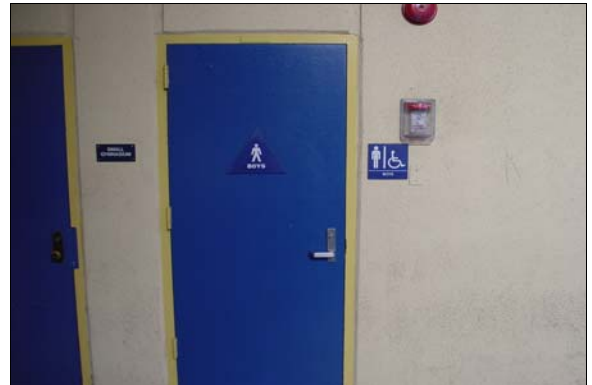
Boys Restroom next to the Small Gym

Finding: There is gender use signage on the door and signage indicating accessibility on the latch side of the entry door of the restroom. The signage is not centered 60 inches above the floor.

Full Rec Remount the signage so it is centered 60 inches above the ground surface

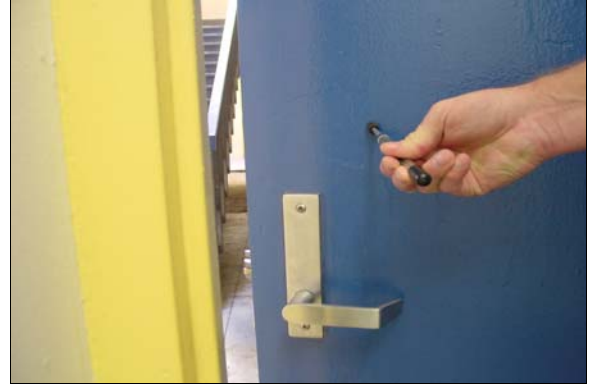
Boys Restroom next to the Small Gym

Finding: The door opening force for the interior entrance door to the restroom is greater than 5 pounds.

Full Rec Adjust the closer on the interior entrance door to the restroom to a maximum door opening force of 5 pounds (see CBC 1133B.2.5.1 and ADAAG 4.13.11).

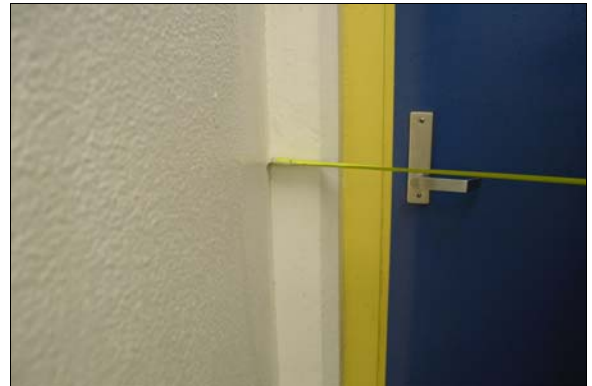
Boys Restroom next to the Small Gym

Finding: There is less than 12 inches of clearance on the latch side of the entrance door to the restroom from the push side.

Full Rec Provide at least 12 inches of latch side clearance or install an automatic door opening device complying with ADAAG 4.13.12 and ANSI/BHMA A156.10, 1985, standards.

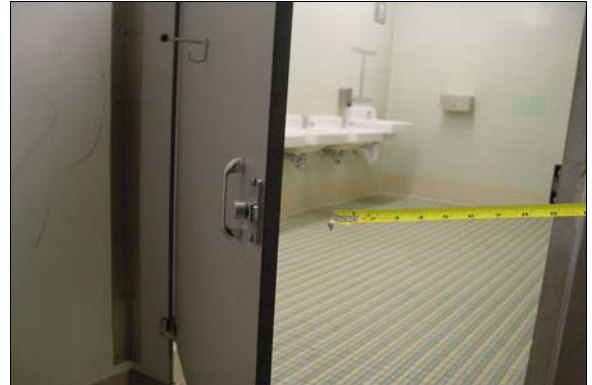
Boys Restroom next to the Small Gym

Finding: The door to the accessible toilet compartment does not close automatically or have accessible hardware.

Full Rec Provide an automatic door closer, spring hinge, pull bar or accessible handle mounted on the inside of the door. Accessible hardware on the inside and outside of the accessible toilet compartment shall be equipped with a loop or U-shaped handle mounted immediately below the latch. The latch shall be flip-over style, sliding or other hardware not requiring grasping or twisting.

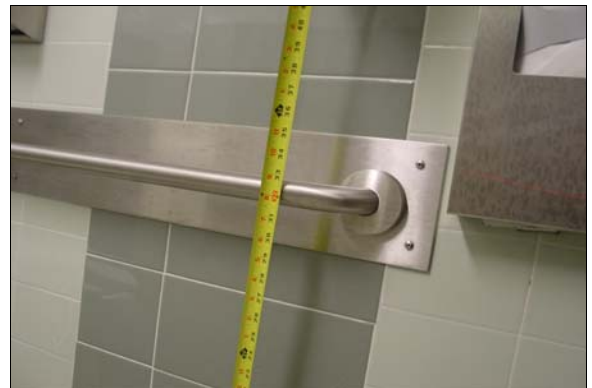
Boys Restroom next to the Small Gym

Finding: The height of the side and back grab bar in the restroom is less than 33 inches above the finished floor.

Full Rec Remount the side and back grab bar in the restroom so that the height of the gripping surface is centered at 33 inches above the finished floor.

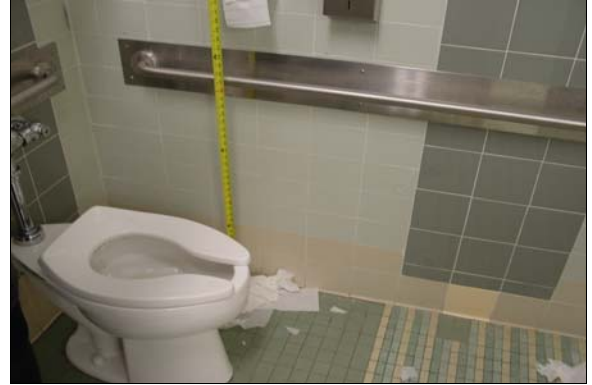
Boys Restroom next to the Small Gym

Finding: The toilet paper dispenser interferes with the use of the side grab bar and is not within 12 inches of the front edge of the toilet.

Full Rec Remount the toilet paper dispenser so it does not interfere with the use of the side grab bar and is within 12 inches of the front edge of the toilet.

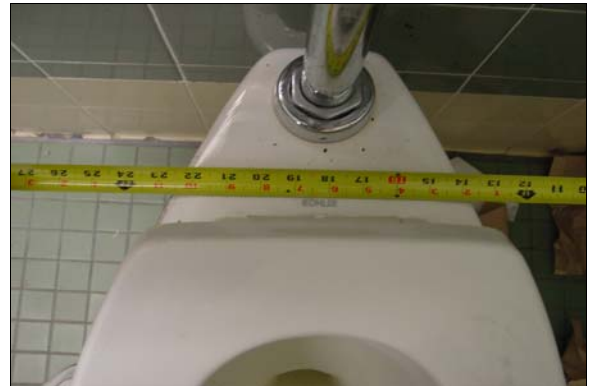
Boys Restroom next to the Small Gym

Finding: The distance from the center of the toilet to the nearest side wall is greater than 18 inches.

Full Rec Relocate the toilet so that the distance from the centerline of the toilet to the nearest side wall is exactly 18 inches (see ADAAG Figure 28).

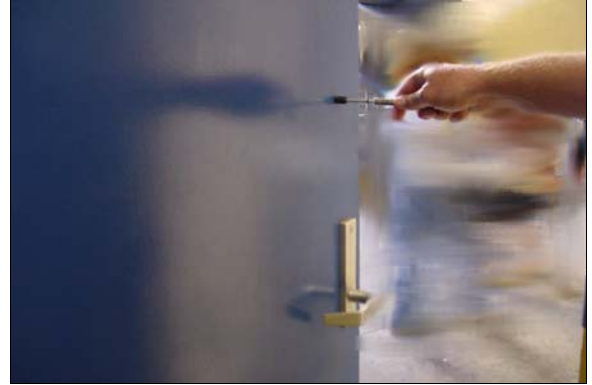
Girls Restroom next to the Small Gym

Finding: The door opening force for the interior entrance door to the restroom is greater than 5 pounds.

Full Rec Adjust the closer on the interior entrance door to the restroom to a maximum door opening force of 5 pounds (see CBC 1133B.2.5.1 and ADAAG 4.13.11).

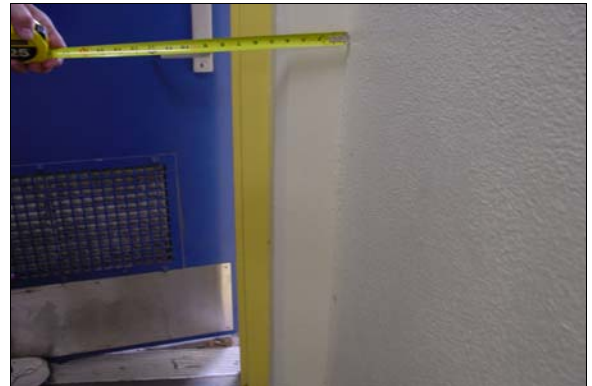
Girls Restroom next to the Small Gym

Finding: There is less than 12 inches of clearance on the latch side of the entrance door to the restroom from the push side.

Full Rec Provide at least 12 inches of latch side clearance or install an automatic door opening device complying with ADAAG 4.13.12 and ANSI/BHMA A156.10, 1985, standards.

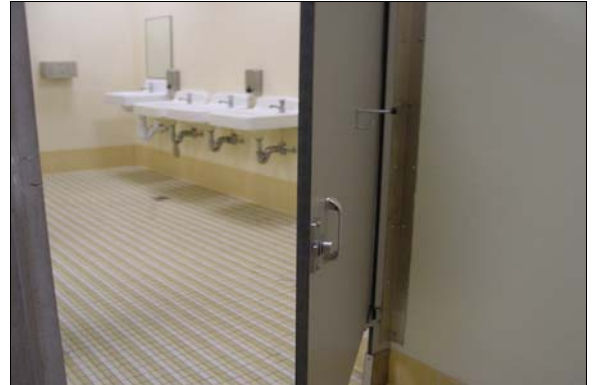
Girls Restroom next to the Small Gym

Finding: The door to the accessible toilet compartment does not close automatically or have accessible hardware.

Full Rec Provide an automatic door closer, spring hinge, pull bar or accessible handle mounted on the inside of the door. Accessible hardware on the inside and outside of the accessible toilet compartment shall be equipped with a loop or U-shaped handle mounted immediately below the latch. The latch shall be flip-over style, sliding or other hardware not requiring grasping or twisting.

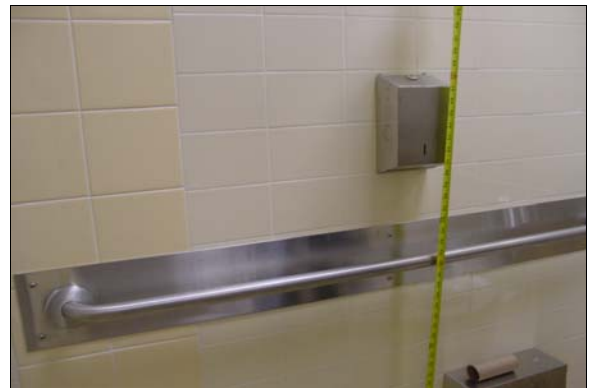
Girls Restroom next to the Small Gym

Finding: The height of the side and back grab bar in the restroom is less than 33 inches above the finished floor.

Full Rec Remount the side and back grab bar in the restroom so that the height of the gripping surface is centered at 33 inches above the finished floor. Grab bars must be able to support a point load of at least 250 pounds and shall be less than the allowable shear stress of the grab bar material.

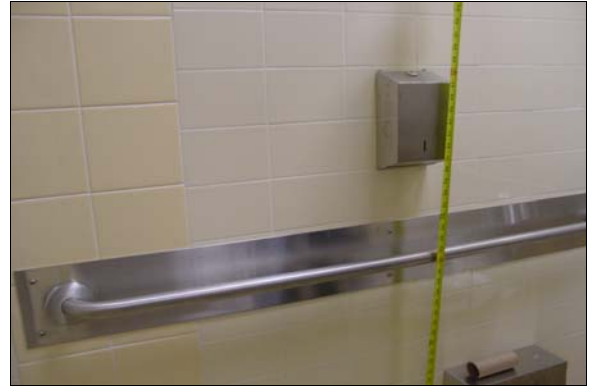
Girls Restroom next to the Small Gym

Finding: The toilet paper dispenser interferes with the use of the side grab bar.

Full Rec Remount the toilet paper dispenser so it does not interfere with the use of the side grab bar and is within 12 inches of the front edge of the toilet.

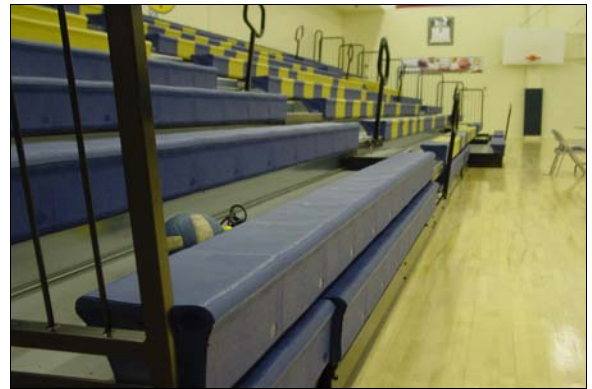
Gymnasium in Building 100

Finding: There are new pullout bleachers provide on both side of the gymnasium. The approximate spectator seating capacity in the gymnasium is greater than 800. At the time of inspection there were no designated wheelchair seating spaces that were identified by the international symbol of accessibility.

Full Rec Provide the compliant number of accessible wheelchair seating locations with at least one fixed companion seat provided next to each accessible wheelchair seating area (see ADAAG 4.33.3 and ADAAG Figure 46). Both the home and visitors side bleachers should have several accessible wheelchair locations with companion seating that provides a line of sight comparable to those of the general public in the gymnasium. Where total seating capacity exceeds 300, accessible wheelchair seating spaces shall be provided in more than one location (see CBC 1104B.3.5 and ADAAG 4.33.3.) Accessible seating areas must be identified with the ISA Symbol.
