Site Survey of Selected Items
for
Compliance with the Americans with Disabilities Act
(ADAAG)
and
Title 24 of the CBC

The site survey of 32nd Street School was conducted on
February 27, 2007 during a spot check for compliance with the
Americans with Disabilities Act Guidelines (ADAAG)
and
Title 24 of the CBC

Facility Name: 32nd Street School

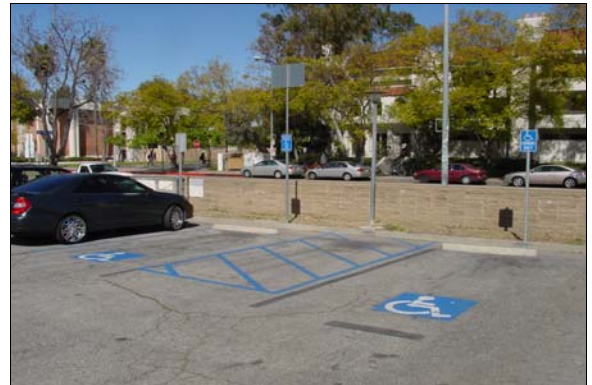
Accessible Parking

Finding: There are two accessible parking spaces out of approximately 30 parking spaces which is sufficient in number for compliance. The left space is not 108 inches wide and the right space is not outlined on the right side. The accessible parking spaces share a "van-accessible" access aisle measuring 97 inches wide. The access aisle does not contain "NO PARKING" in 12" high white letters.

Full Rec Two out of the 30 marked parking spaces meets the number required for compliance. Restripe the designated accessible parking spaces to create one van-accessible and one standard accessible parking space, each measuring at least 108 inches wide and 216 inches long with an access aisle measuring at least 96 inches wide (8 feet) shared between the two accessible parking spaces (see CBC 1129B). The accessible parking space with the access aisle to the right of the space shall be designated "van-accessible." Add the words NO PARKING in 12 inch high white letters at the entrance to each accessible parking access aisle.

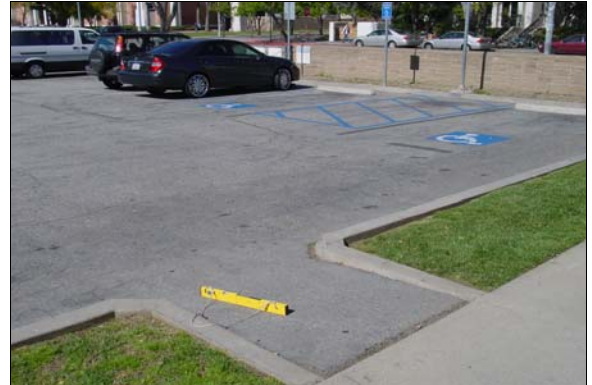
Accessible Parking

Finding: The location of the accessible parking spaces requires individuals with disabilities to travel behind parked cars other than their own.

Full Rec Stripe a 48-inch access aisle at the head of the accessible parking spaces and at the general parking spaces. Install a wheelstop at the head of the accessible parking spaces and at the general parking spaces. Wheelstops shall be used to prevent vehicles from encroaching into access aisles or walkways, but shall not present addition encroachment into those areas (see CBC 1129B.4.3).

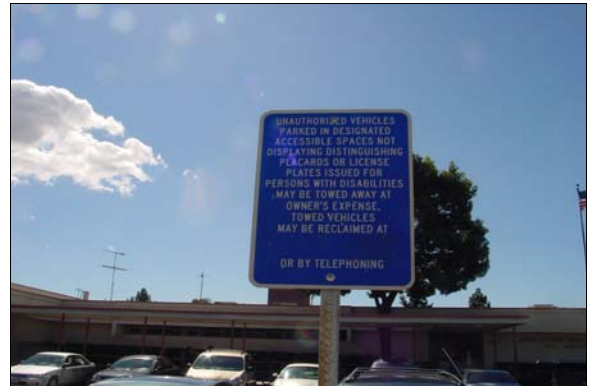
Accessible Parking

Finding: There is warning signage posted at the entrance from 32nd Street regarding unauthorized use of accessible parking spaces in the parking lot, however, the blank spaces which should furnish the point of contact and telephone number for reclaiming towed vehicles have been left blank.

Full Rec Fill in the blank spaces which are required to furnish the point of contact and telephone number for reclaiming towed vehicles with the appropriate information as a permanent part of the sign and maintain the currency of the information (see CBC 1129B.5). Make sure to add the CVC 22511.8(a)(d) to the sign.

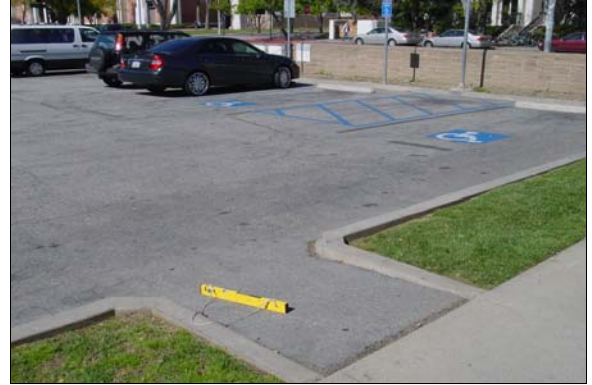
Curb Ramp next to the Accessible Parking Spaces

Finding: The width of the curb-cut ramp is less than 48 inches. The transition at the top landing is abrupt. There are no 12 inch grooved boarders or detectable warning surface of truncated domes.

Full Rec Replace the concrete curb-cut ramp with a concrete curb-cut ramp at least 48 inches in width that provides a slope no greater than 8.33% and a cross slope no greater than 2%.

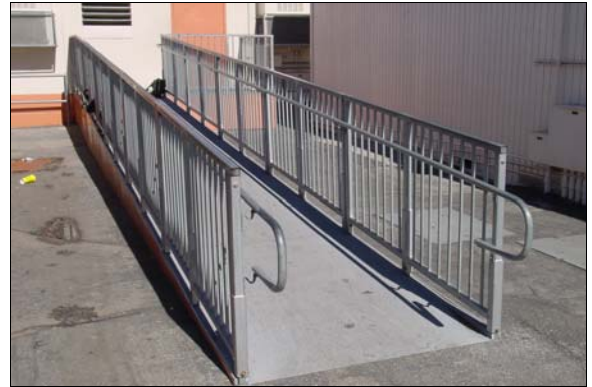
Ramp to Portable 24

Finding: The bottom handrail extensions due not return to parallel and the ends due not return smoothly to the post. The top left handrail does not return to parallel.

Full Rec Provide compliant handrails on the ramp.

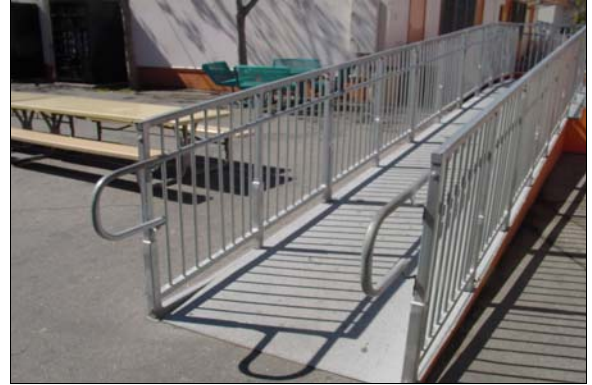
Ramp to Portable 31

Finding: The top left handrail does not return to parallel. The bottom handrail extensions due not return to parallel and the ends due not return smoothly to the post.

Full Rec Provide compliant handrails on the ramp.

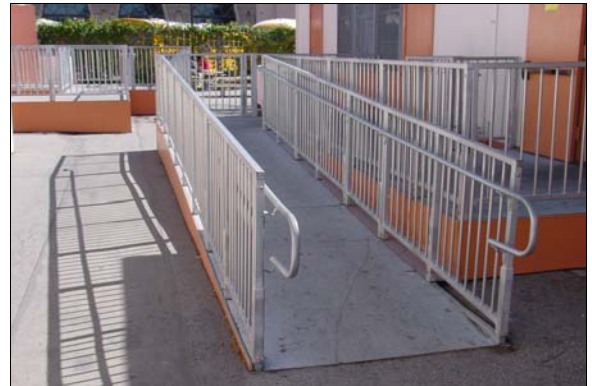
Ramp to Portable 33

Finding: The top left handrail does not return to parallel. The ends of the bottom handrails due not return smoothly to the post.

Full Rec Provide compliant handrails on the ramp.

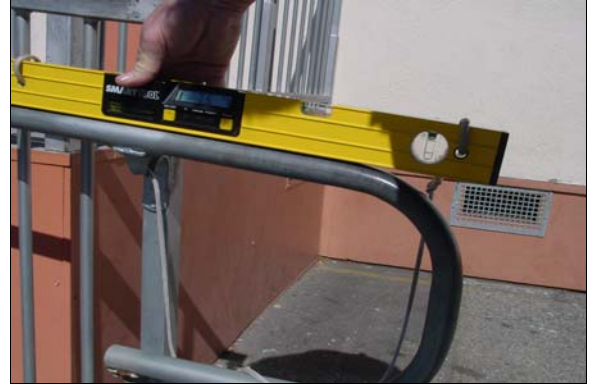
Ramp to Portables 13 &14

Finding: The first run top left and second run top right handrail extensions do not return to parallel. The bottom handrail extensions due not return to parallel and the ends due not return smoothly to the post

Full Rec Provide compliant handrails on the ramp.

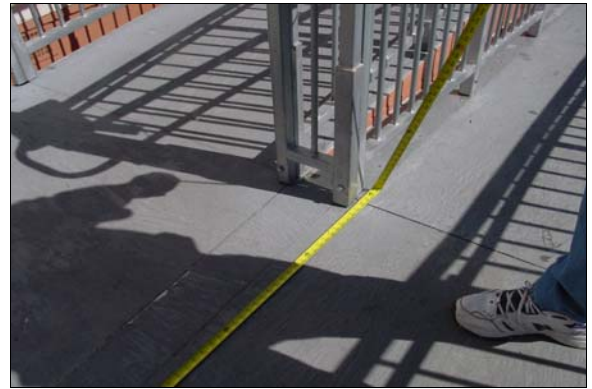
Ramp to Portables 13 &14

Finding: The ramp changes direction more than 30 degrees. The length of the intermediate switchback landing on the ramp is less than 72 inches.

Full Rec Modify or replace the intermediate switchback landing on the ramp to provide at least 72 inches in length in the direction of the run of the ramp and at least 96 inches in width to incorporate the minimum width of each run of the ramp and the distance between the parallel runs (see CBC 1133B.5.4.6 and ADAAG 4.8.4).

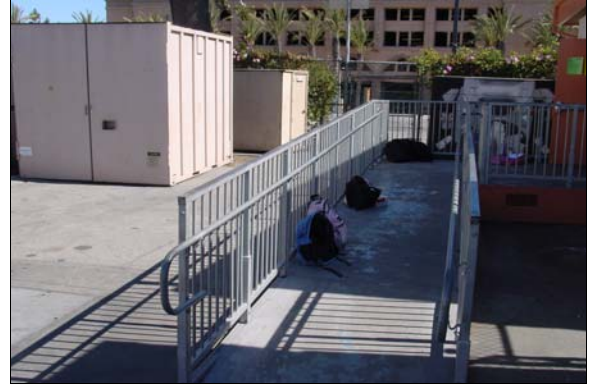
Ramp to Portables 17 &18

Finding: The bottom handrail extensions due not return to parallel and the ends due not return smoothly to the post. The top left handrail does not return to parallel.

Full Rec Provide compliant handrails on the ramp.

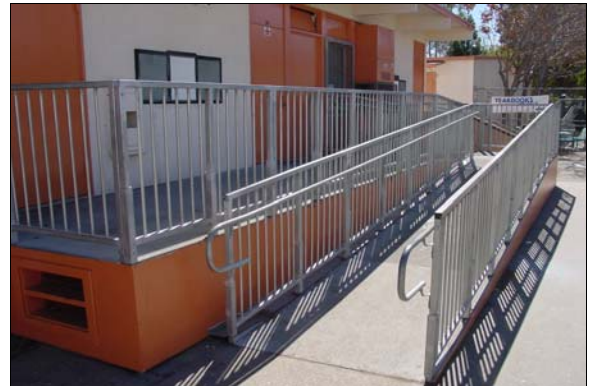
Ramp to Portables 28 & 29

Finding: The ends of the bottom handrails due not return smoothly to the post. The top left handrail extension does not return to parallel.

Full Rec Provide compliant handrails on the ramp.

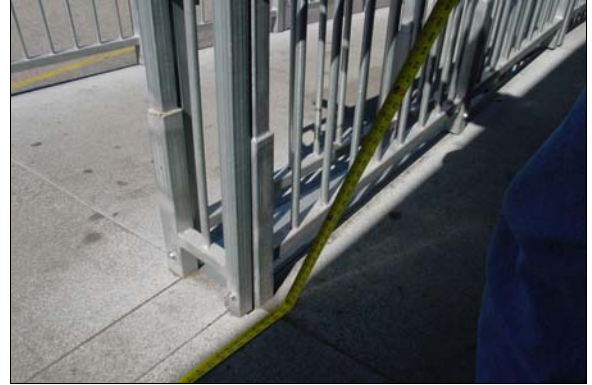
Ramp to Portables 28 & 29

Finding: The ramp changes direction more than 30 degrees. The length of the intermediate switchback landing on the ramp is less than 72 inches.

Full Rec Modify or replace the intermediate switchback landing on the ramp to provide at least 72 inches in length in the direction of the run of the ramp and at least 96 inches in width to incorporate the minimum width of each run of the ramp and the distance between the parallel runs (see CBC 1133B.5.4.6 and ADAAG 4.8.4).

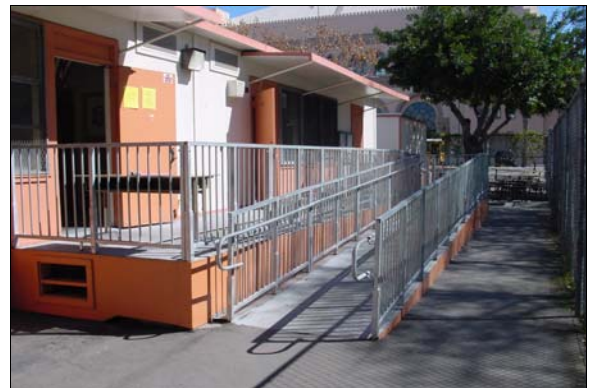
Ramp to Portables 34 & 35

Finding: The 12-inch extension of the first run top right handrail extension does not return to parallel. The ends of the bottom handrails do not return smoothly to the post.

Full Rec Provide compliant handrails on the ramp.

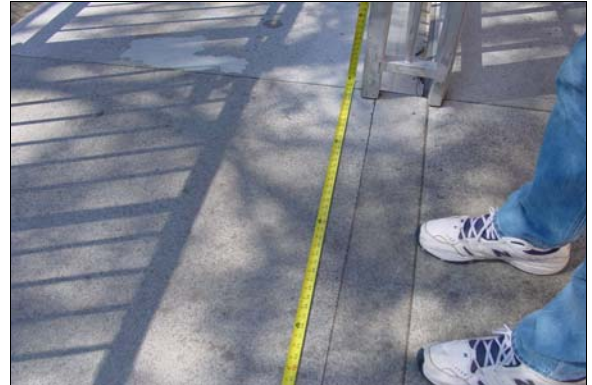
Ramp to Portables 34 & 35

Finding: The ramp changes direction more than 30 degrees. The length of the intermediate switchback landing on the ramp is less than 72 inches.

Full Rec Modify or replace the intermediate switchback landing on the ramp to provide at least 72 inches in length in the direction of the run of the ramp and at least 96 inches in width to incorporate the minimum width of each run of the ramp and the distance between the parallel runs (see CBC 1133B.5.4.6 and ADAAG 4.8.4).

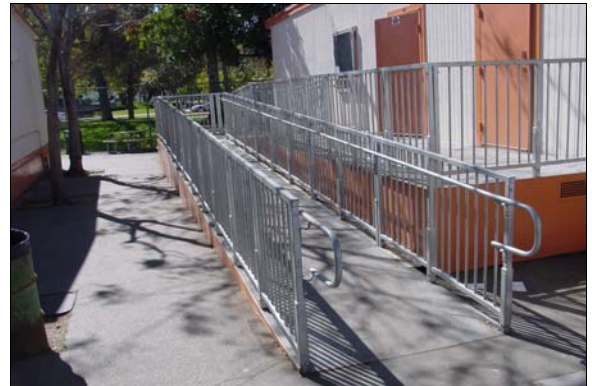
Ramp to Portables 36 & 37

Finding: The bottom left and top right handrail extensions due not return to parallel. The ends of the bottom handrails due not return smoothly to the post.

Full Rec Provide compliant handrails on the ramp.

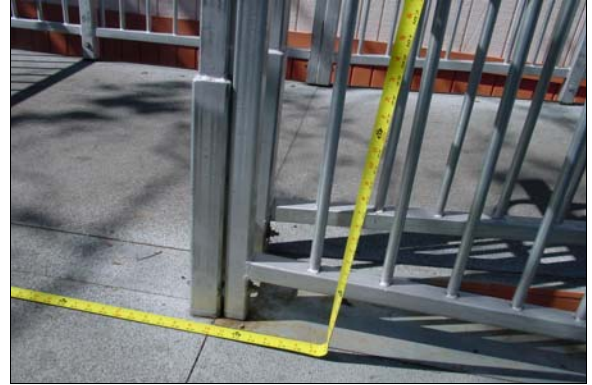
Ramp to Portables 36 & 37

Finding: The ramp changes direction more than 30 degrees. The length of the intermediate switchback landing on the ramp is less than 72 inches.

Full Rec Modify or replace the intermediate switchback landing on the ramp to provide at least 72 inches in length in the direction of the run of the ramp and at least 96 inches in width to incorporate the minimum width of each run of the ramp and the distance between the parallel runs (see CBC 1133B.5.4.6 and ADAAG 4.8.4).

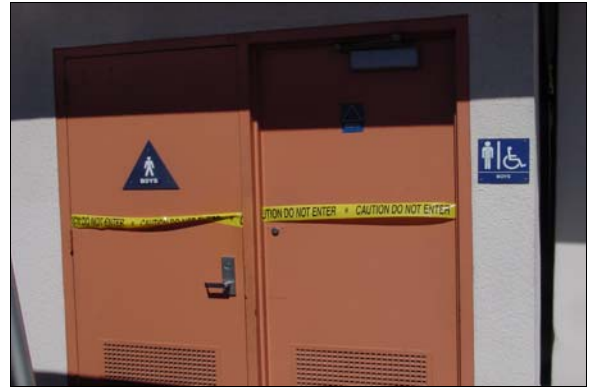
Boys Restroom next to the Cafeteria

Finding: The door opening force for the interior entrance door to the restroom is greater than 5 pounds.

Full Rec Adjust the closer on the interior entrance door to the restroom to a maximum door opening force of 5 pounds (see CBC 1133B.2.5.1 and ADAAG 4.13.11).

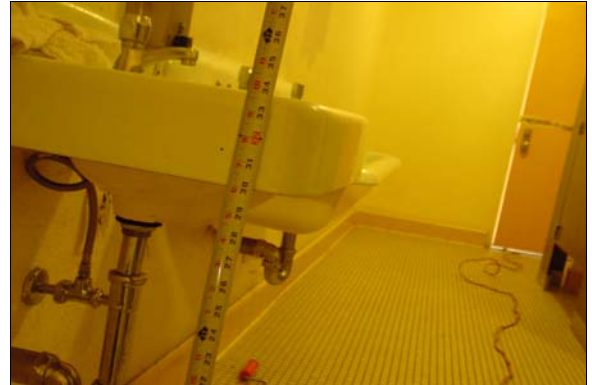
Boys Restroom next to the Cafeteria

Finding: The pipes under the lavatory in the restroom do not provide protection against contact.

Full Rec Insulate or otherwise configure pipes under the lavatory designated to be accessible in the restroom to protect against contact (see ADAAG 4.19.4). Make certain there are no sharp or abrasive surfaces under the lavatory.

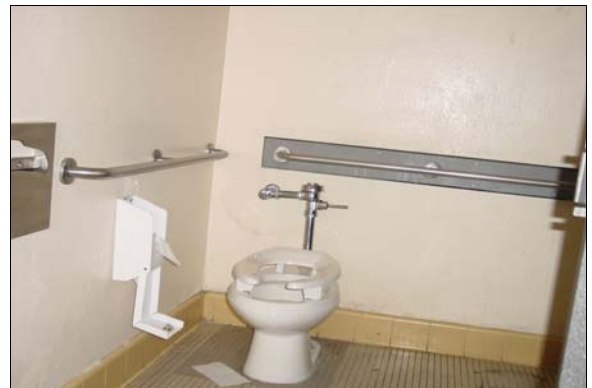
Boys Restroom next to the Cafeteria

Finding: The height of the side and back grab bar is greater than 33 inches above the finished floor. The side grab bar does not extend 54 inches from the back wall

Full Rec Remount the side and back grab bar so the height of the gripping surface is centered at 33 inches above finished floor. The side grab bar must extend 54 inches from the back wall.

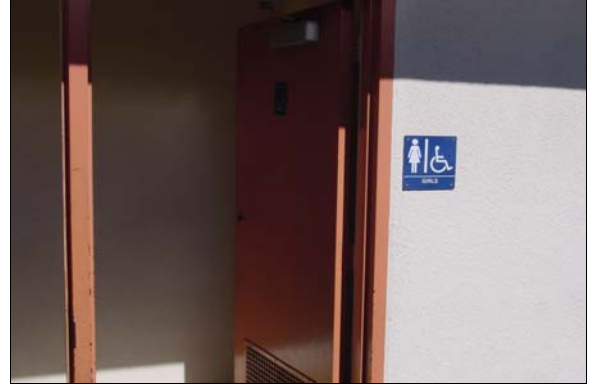
Girls Restroom next to the Cafeteria

Finding: The door opening force for the interior entrance door to the restroom is greater than 5 pounds.

Full Rec Adjust the closer on the interior entrance door to the restroom to a maximum door opening force of 5 pounds (see CBC 1133B.2.5.1 and ADAAG 4.13.11).

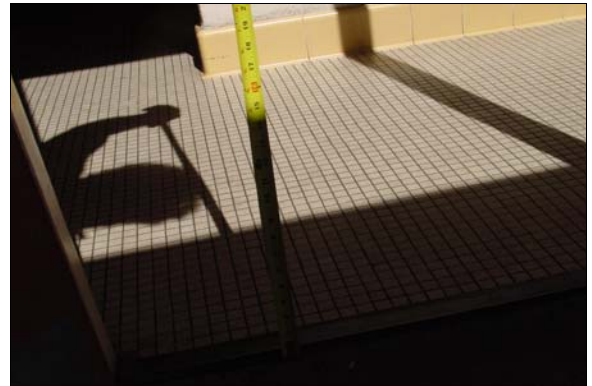
Girls Restroom next to the Cafeteria

Finding: The height of the threshold at the entrance door is greater than 1/2 inch.

Full Rec Modify or replace the threshold to provide a smooth transition. The threshold should not exceed a beveled 1/2 inch.

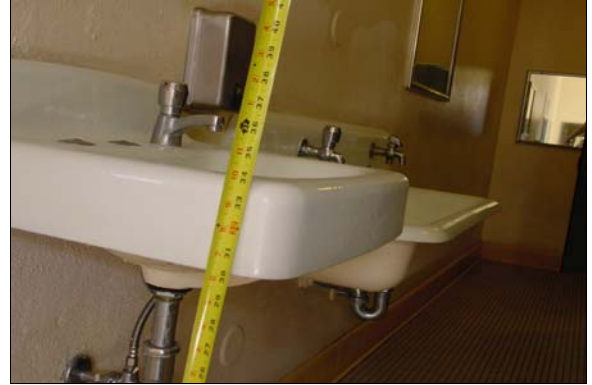
Girls Restroom next to the Cafeteria

Finding: The pipes under the lavatory in the restroom do not provide protection against contact.

Full Rec Insulate or otherwise configure pipes under the lavatory designated to be accessible in the restroom to protect against contact (see ADAAG 4.19.4). Make certain there are no sharp or abrasive surfaces under the lavatory.

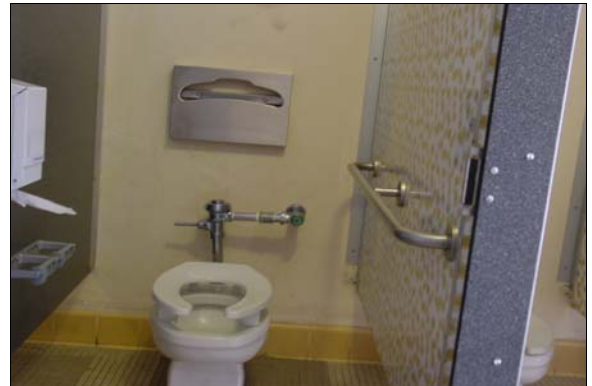
Girls Restroom next to the Cafeteria

Finding: There is only one grab bar in the alternate toilet compartment.

Full Rec Install a 42/48-inch side grab bar at a height of 33 inches above the finished floor in the alternate toilet compartment.

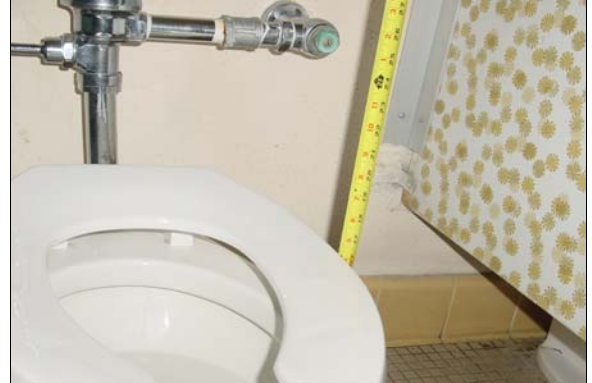
Girls Restroom next to the Cafeteria

Finding: The height of the toilet seat in the alternate toilet compartment is less than 17 inches above the finished floor.

Full Rec Remove or modify the toilet so the seat height is between 17 inches and 19 inches above the finished floor (see ADAAG 4.16.3).

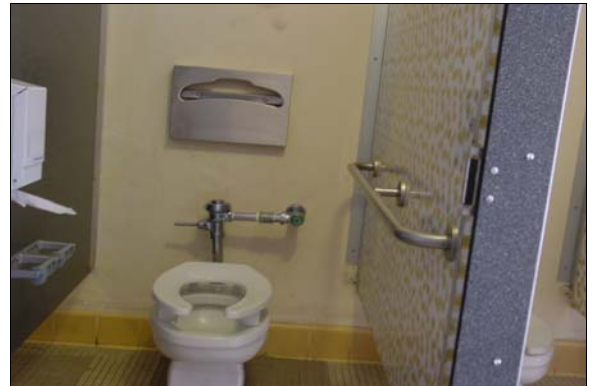
Girls Restroom next to the Cafeteria

Finding: The seat cover dispenser in the alternate toilet compartment is mounted behind the toilet and does not have clear floor space.

Full Rec Relocate the seat cover dispenser so the height is no greater than 40 inches above the finished floor (see CBC 1115B.9.2). Make certain that the location of the seat cover dispenser does not interfere with the use of a grab bar and provides sufficient clear floor space.

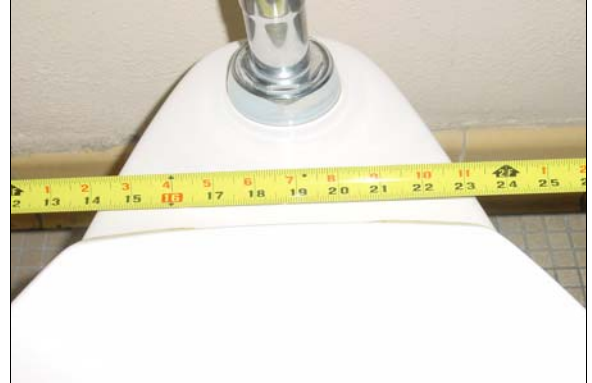
Girls Restroom next to the Cafeteria

Finding: The distance from the center of the toilet to the nearest side wall in the standard accessible toilet compartment is greater than 18 inches.

Full Rec Relocate the toilet so that the distance from the centerline of the toilet to the nearest side wall is exactly 18 inches (see ADAAG Figure 28).

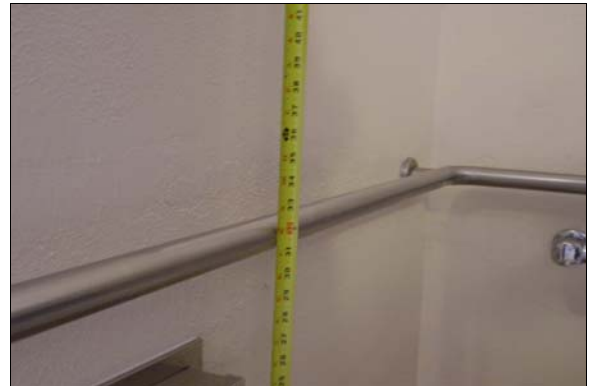
Girls Restroom next to the Cafeteria

Finding: The height of the side and back grab bar in the accessible toilet compartment is less than 33 inches above the finished floor.

Full Rec Remount the side and back grab bar so the height of the gripping surface is centered at 33 inches above the finished floor. The side grab bar must extend 54 inches from the back wall.

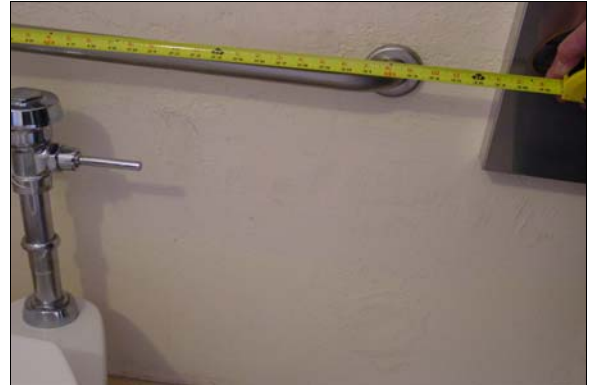
Girls Restroom next to the Cafeteria

Finding: The length of the back grab bar in the accessible toilet compartment is less than 36 inches.

Full Rec Replace the back grab bar with a 36-inch back grab bar complying with ADAAG 4.26 and CBC 1115B.8. Grab bars must be able to support a point load of at least 250 pounds and shall be less than the allowable shear stress of the grab bar material.

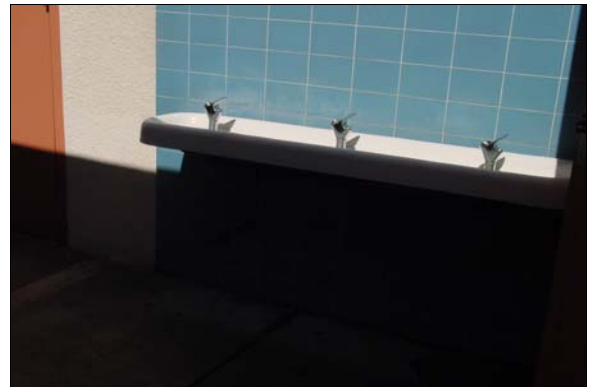
Drinking Fountain Outside the Cafeteria

Finding: The drinking fountain is not a Hi - Low type fountain and is not located in an alcove. The fountain is a protruding object.

Full Rec Fifty percent of the drinking fountains on primary paths of travel shall be accessible (see CBC 1117B.1 and ADAAG 4.15). Install a "high-low" fountain design to comply with both state and federal requirements and install a side rail or wing wall next to each side of the fountain. Provide at least 30 inches in width and 48 inches in depth in front of the drinking fountain. The height of the spout outlet shall not exceed 36 inches in height. Fountain controls shall be accessible. The spout shall direct the water flow at least 4 inches high and in a trajectory that is parallel or nearly parallel to the front of the drinking fountain. Wall-mounted drinking fountains shall provide a minimum knee clearance height of 27 inches, 30 inches in width and between 18 inches and 19 inches in fountain
