Site Survey of Selected Items  
for  
Compliance with the Americans with Disabilities Act  
(ADAAG)  
and  
Title 24 of the CBC

The site survey of Ellen Ochoa Learning Center was conducted on February 27, 2007 during a spot check for compliance with the Americans with Disabilities Act Guidelines (ADAAG) and Title 24 of the CBC

# Facility Name: Ellen Ochoa Learning Center

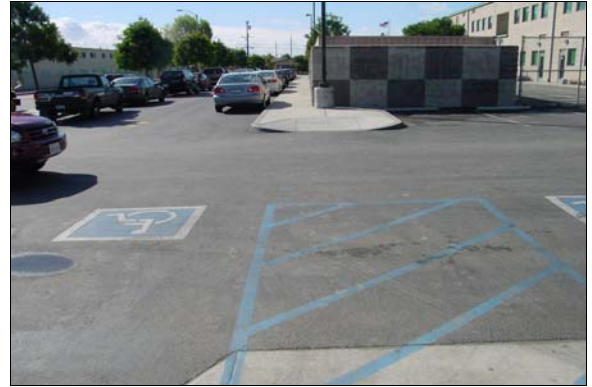
Accessible Parking

**Finding:** There is no crosswalk provided on the path of travel from the accessible parking space to the facility. The required accessible route crosses a vehicular way.

**Full Rec** Stripe a crosswalk not less than 48 inches wide on the path of travel to the accessible entrance. Provide a level surface that does not exceed a slope greater than 5%. Cross slopes shall not exceed 2%. Detectable warnings should be placed at the entrance and exit of the crosswalk.

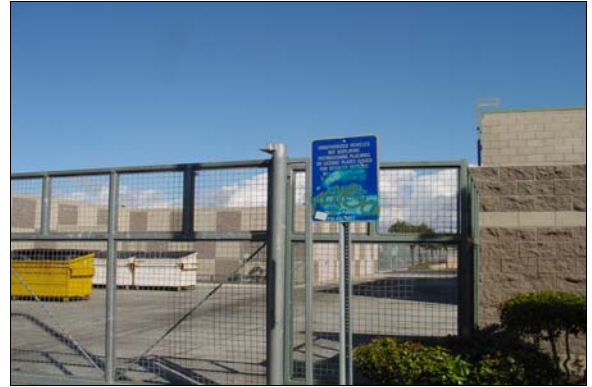
Accessible Parking next to the MPR

**Finding:** There is warning signage posted at the entrance from Live Oak regarding unauthorized use of accessible parking spaces in the parking lot. The lettering on the sign has been vandalized and the California Vehicle Code is not present.

**Full Rec** Fill in the blank spaces which are required to furnish the point of contact and telephone number for reclaiming towed vehicles with the appropriate information as a permanent part of the sign and maintain the currency of the information (see CBC 1129B.5). Make sure to add the CVC22511.8(a)(d) to the sign.

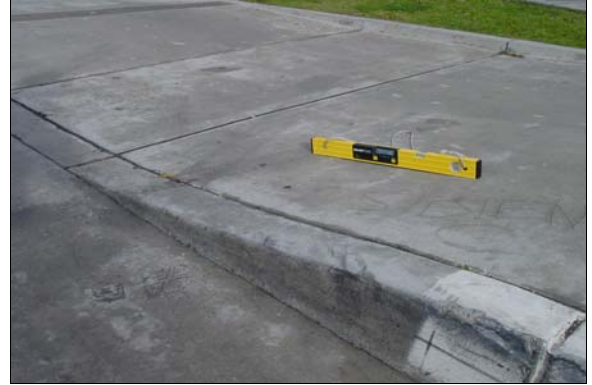
Curb Ramp at the Bus Loading Zone

**Finding:** The slope of the top and bottom landing is greater than 2%. The slope of the side flares is greater than 10%. There is no detectable warning surface of truncated domes.

**Full Rec** Replace the concrete curb-cut ramp with a concrete curb-cut ramp at least 48 inches in width that provides a slope no greater than 8.33% and a cross slope no greater than 2%. The slope of the top landing shall not exceed 2% and shall provide at least 48 inches in length of maneuvering clearance. The bottom landing shall provide a smooth transition. The side flares shall be no greater in slope than 10%. Provide a compliant 36 inch strip of truncated domes on the curb ramp.

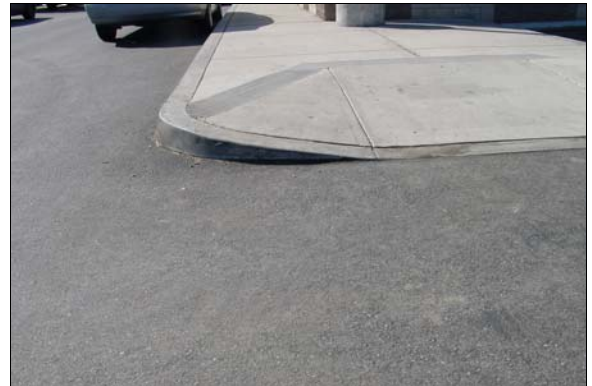
Curb Ramp at the Florence Avenue Parking Lot

**Finding:** The slope of the side flares is greater than 10%. There is no detectable warning surface of truncated domes.

**Full Rec** Replace the concrete curb-cut ramp with a concrete curb-cut ramp at least 48 inches in width that provides a slope no greater than 8.33% and a cross slope no greater than 2%. The slope of the top landing shall not exceed 2% and shall provide at least 48 inches in length of maneuvering clearance. The bottom landing shall provide a smooth transition. The side flares shall be no greater in slope than 10%. Provide a compliant 36 inch strip of truncated domes.

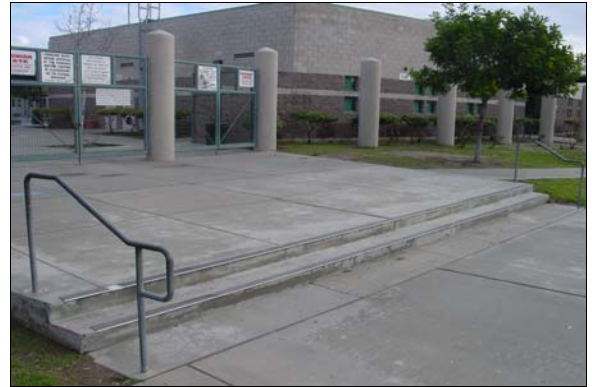
Exterior Stairs next to the Bus Loading Zone

**Finding:** The width of the stairway is greater than 88 inches and does not have a middle handrail.

**Full Rec** Provide one intermediate handrail for each 88 inches of stairway width. Space intermediate handrails equally across the entire width of the stairway.

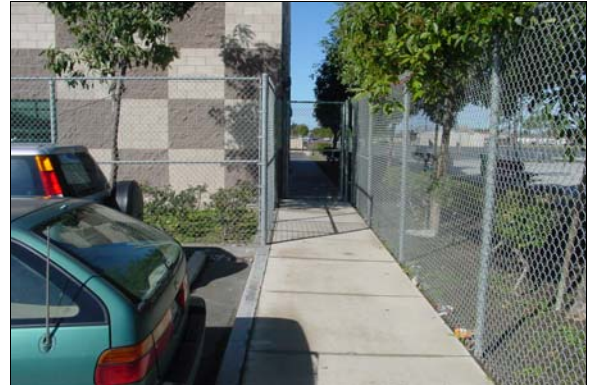
Gate from Florence Avenue Parking to School

**Finding:** The bottom 10 inches of the gate does not provide a smooth, uninterrupted surface, or panel to allow the door to be opened by a wheelchair footrest without creating a trap or hazardous condition.

**Full Rec** Install a panel or replace the gate to provide a smooth, uninterrupted surface for the bottom 10 inches of the door.
