Site Survey of Selected Items
for
Compliance with the Americans with Disabilities Act
(ADAAG)
and
Title 24 of the CBC

The site survey of Miguel Contreras Learning Complex was conducted on February 26, 2007 during a spot check for compliance with the Americans with Disabilities Act Guidelines (ADAAG) and Title 24 of the CBC

Facility Name: Miguel Contreras Learning Complex

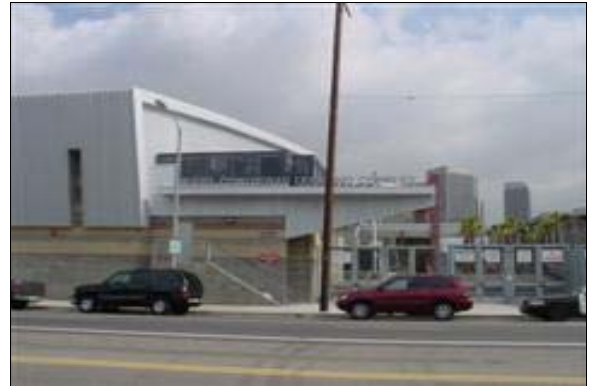
Finding: Miguel Contreras Learning Complex located at 322 Lucas Avenue in Los Angeles California, provides services to students in Grades 9 thru 12. The facility was inspected by Disability Access Consultants, Inc., on February 26, 2007. This is a report of selected items and is not intended as a full report.

Full Rec Any renovation or new construction that occurred after January 26, 1992, is subject to meet full code specifications for the California Building Code and ADAAG requirements. All recommendations in this report are based on ADAAG and CBC title 24 requirements. Consult with your design professional to determine which elements are affected by these requirements. It is recommended that Disability Access Consultants, Inc. is consulted for inspection of any new construction or renovation at the facility.

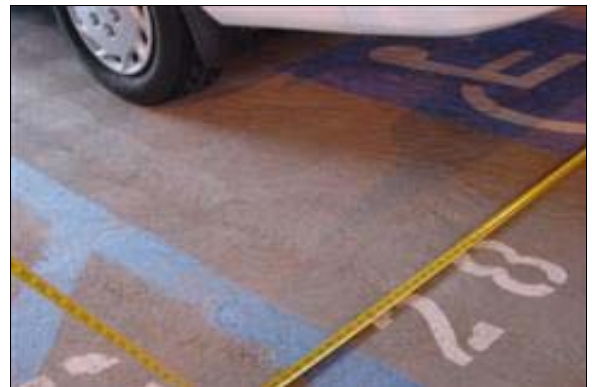
Accessible Parking

Finding: There are five accessible parking spaces which is sufficient in number as required for compliance. Each accessible parking space provided measures less than 108 inches wide. The "van-accessible" access aisle measures 91 inches wide.

Full Rec Restripe the designated accessible parking spaces to create one van-accessible and standard accessible parking spaces, each measuring at least 108 inches wide and 216 inches long. Designate one parking space as "van-accessible". The van-accessible space shall provide an access aisle measuring at least 96 inches wide on the passenger side (right side) of the vehicle space. The additional parking spaces shall each provide an access aisle measuring at least 60 inches wide, that may be shared. Add the words NO PARKING in 12 inch high white letters at the entrance to each accessible parking access aisle.

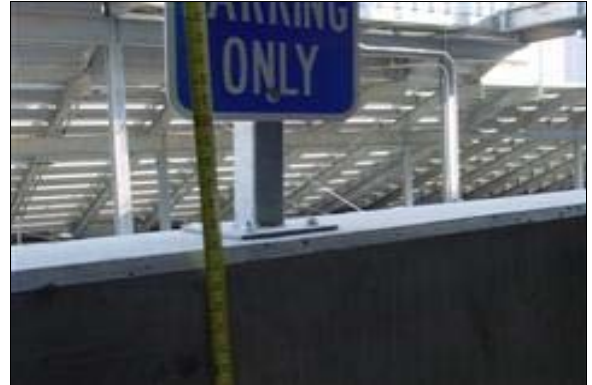
Accessible Parking

Finding: The bottom edge of the post-mounted signage designating the accessible parking space next to the elevator is 48 inches above the level of the parking space and cannot be viewed when a vehicle is parked in the space.

Full Rec Modify the height or replace the post-mounted signage designating the accessible parking space to provide at least 80 inches from the parking space finished grade to the bottom edge of the sign. The sign shall be located so that it cannot be obscured by a vehicle parked in the space (see CBC 1129B.5).

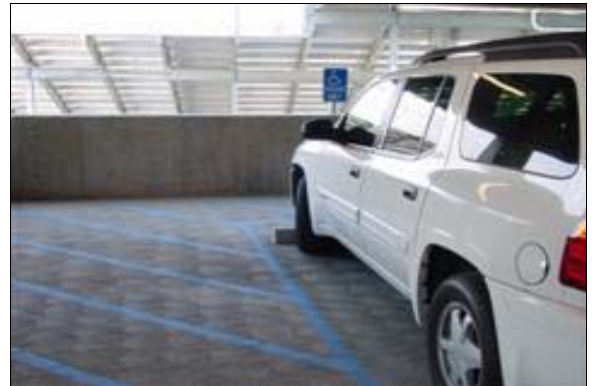
Accessible Parking

Finding: The area between the head aisle and the accessible parking access aisles is level. The pedestrian and vehicular traffic areas are not separated by a ramp, railing, curb or other element.

Full Rec Install a 36 inch wide detectable warning surface at the head aisle entrance to each access aisle. The truncated domes should contrast visually by either light on dark or dark on light which and be an integral part of the walking surface. The detectable warning surface should cover the full width of each access aisle.

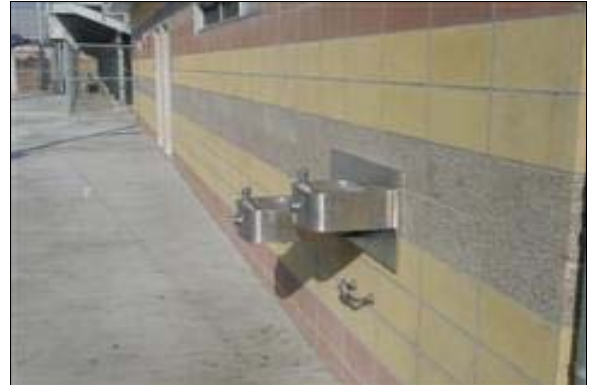
Protruding Objects

Finding: The leading edge of the drinking fountains next to room 4015, and outside the Field House restrooms are more than 4 inches from the wall and greater than 27 inches from the floor and protrudes into the primary path of travel.

Full Rec Install a side rail or wing wall next to each side of the drinking fountains to eliminate its protrusion into the primary path of travel. Make certain to provide sufficient clear floor space in front of the drinking fountain with at least 30 inches in width by 48 inches in length (see CBC 1118B.4 and ADAAG 4.2.4.1).

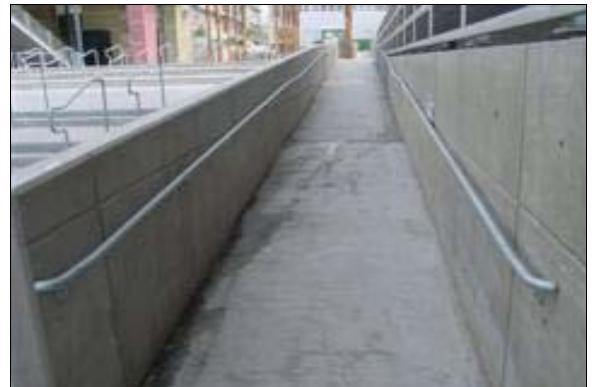
Ramp from Lucas Avenue

Finding: There are no 12-inch extensions beyond the bottom of the ramp.

Full Rec Replace the handrails on each side of the ramp to provide a smooth and continuous gripping surface diameter between 1 1/4 inches to 1 7/8 inches, mounted at a height between 34 inches and 38 inches and shall be at a distance no less than 1 1/2 inches from the adjacent wall. The gripping surface shall be smooth and free from interruptions. The handrails shall provide 12-inch extensions, extending beyond the top and bottom of the ramp, that are parallel to the ground surface and return smoothly to the post or wall.

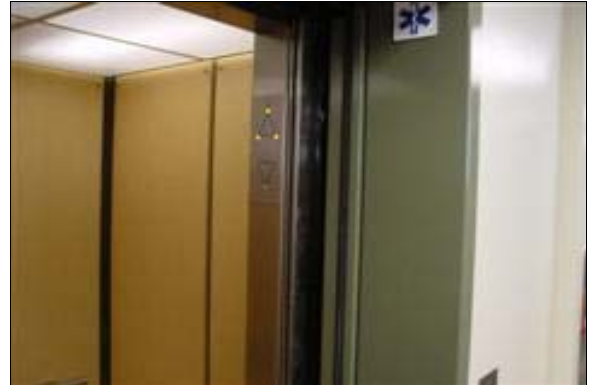
Elevator

Finding: The elevator does not provide chase way signage. There is no Title 19 tactile emergency evacuation signage provided at the elevator.

Full Rec The elevator must be certified and found to be compliant with CBC and ADAAG guidelines as directed by the State of California, Division of the State Architect, Office of Regulation Services, to provide accessibility to programs, services and activities at different levels of the facility. Make certain that the elevator is operational and available for individuals with mobility impairments during all hours the facility is open.

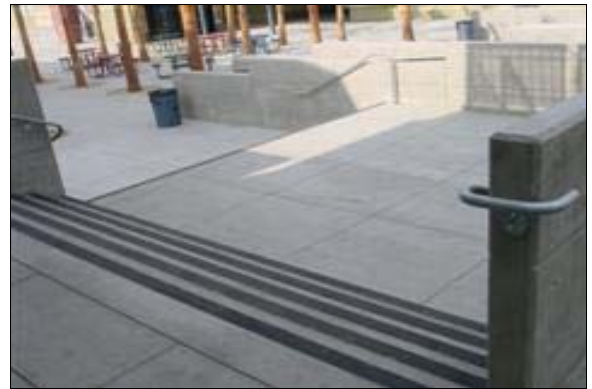
Stairs at Building 3

Finding: The width of the stairway is greater than 88 inches.

Full Rec Provide one intermediate handrail for each 88 inches of stairway width. Space intermediate handrails equally across the entire width of the stairway.

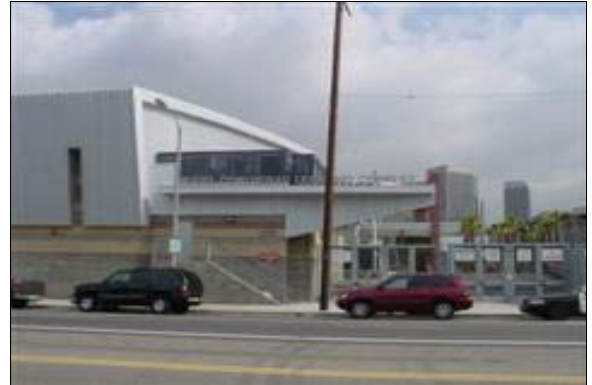
Directional Signage

Finding: There is no directional signage to the accessible entrance from the public right of way or other common use areas.

Full Rec Install directional signage to each common area complying with CBC 1117B.5 and ADAAG 4.30.

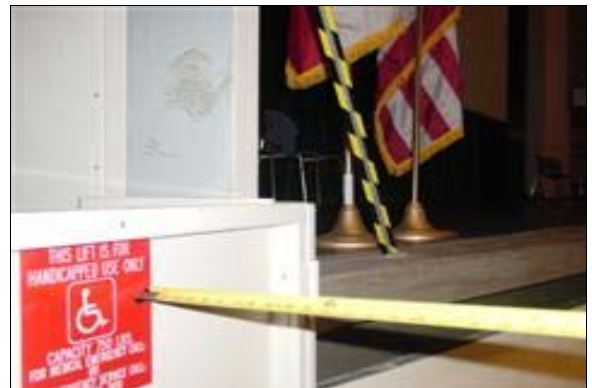
Platform Lift

Finding: The signage on the platform lift contains the word "Handicapped."

Full Rec Modify or replace the signage so it does not contain the word "Handicapped."

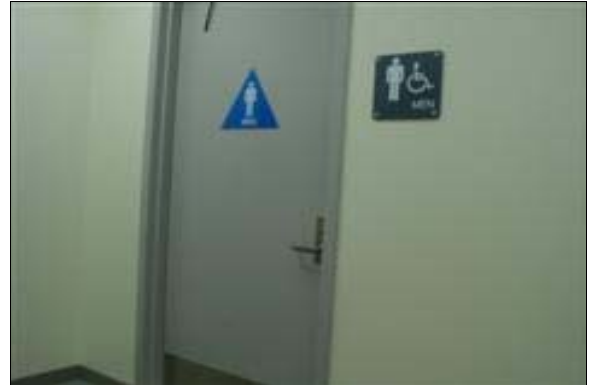
Mens Restroom at Rear of Stage

Finding: There is signage indicating accessibility on the entry door to the restroom. The signage is centered 60 inches above the floor on the latch side of the entrance door and includes Braille and raised lettering, gender use symbol and the ISA symbol.

Full Rec The restroom is designated accessible and should be made an accessible restroom for the facility. Monitor signage for continued compliance with CBC 1115B.5, ADAAG 4.1.2(7) and ADAAG 4.1.6(3)(e) and ADAAG 4.30.

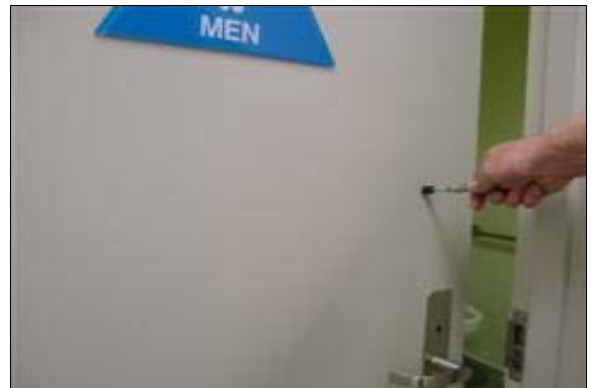
Mens Restroom at Rear of Stage

Finding: The door opening force for the interior entrance door to the restroom is greater than 5 pounds.

Full Rec Adjust the closer on the interior entrance door to the restroom to a maximum door opening force of 5 pounds (see CBC 1133B.2.5.1 and ADAAG 4.13.11).

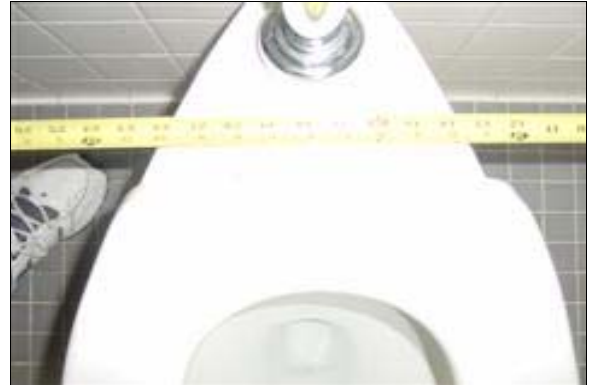
Mens Restroom at Rear of Stage

Finding: The distance from the center of the toilet to the nearest side wall in the stall designated to be accessible in the restroom is 17 3/4 inches.

Full Rec Relocate the toilet or stall side wall so that the distance from the centerline of the toilet to the nearest side wall in the stall designated to be accessible in the restroom is exactly 18 inches (see ADAAG Figure 28).

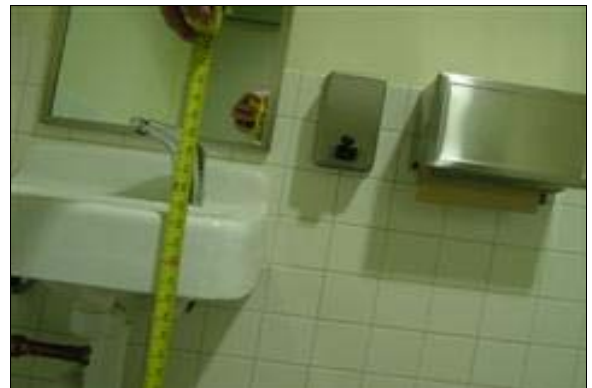
Mens Restroom at Rear of Stage

Finding: The height of the rim surface of the lavatory is 34 1/2 inches.

Full Rec Relocate or replace the lavatory designated to be accessible in the restroom to provide a maximum rim surface height of no greater than 34 inches above the finished floor (see ADAAG 4.19.2).

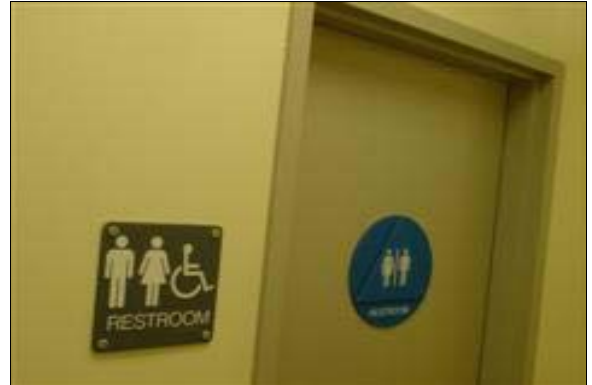
Unisex Staff Restroom in Office

Finding: There is signage indicating accessibility on the entry door to the restroom. The signage is centered 60 inches above the floor on the latch side of the entrance door and includes Braille and raised lettering, gender use symbol and the ISA symbol.

Full Rec The restroom is designated accessible and should be made an accessible restroom for the facility. Monitor signage for continued compliance with CBC 1115B.5, ADAAG 4.1.2(7) and ADAAG 4.1.6(3)(e) and ADAAG 4.30.

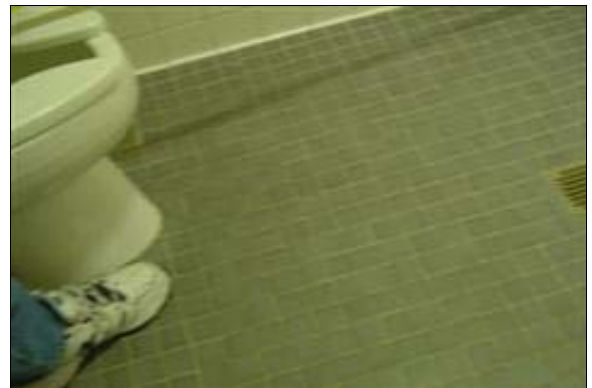
Unisex Staff Restroom in Office

Finding: This restroom is not accessible and cannot be easily altered. There is not sufficient clear floor space in the restroom. The inward swing of the entrance door reduces the clear floor space in the restroom.

Full Rec Consult a design professional to modify the restroom. One or more walls may need to be moved to provide sufficient clear floor space to inscribe a 60-inch diameter turning radius in the restroom. The door swing may be reversed to provide greater clear floor space in the restroom.

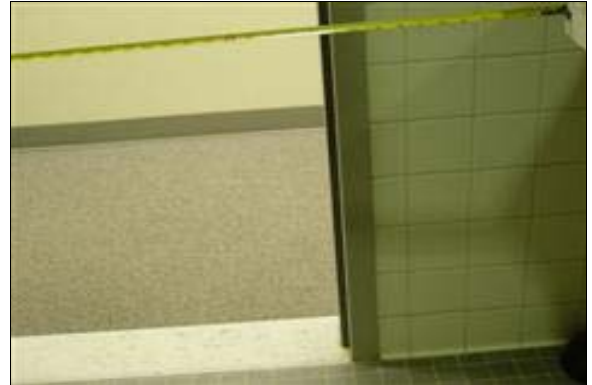
Unisex Staff Restroom in Office

Finding: There is 12 inches on the latch side of the entrance door to the restroom from the pull side.

Full Rec Provide at least 18 inches of latch side clearance at the entrance door to the restroom from the pull side (see ADAAG 4.13.6 and Figure 25). Otherwise, an automatic door opening device may be required to provide an accessible entrance.

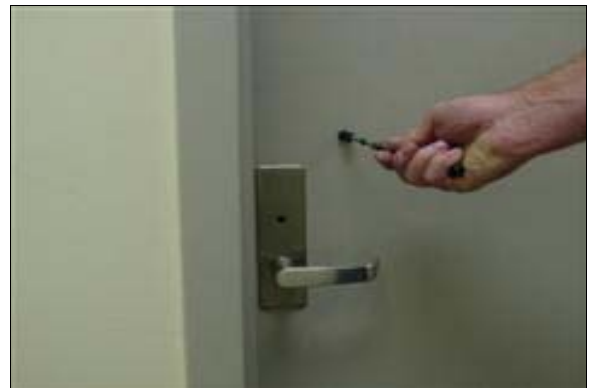
Unisex Staff Restroom in Office

Finding: The door opening force for the interior entrance door to the restroom is 12 pounds.

Full Rec Adjust the closer on the interior entrance door to the restroom to a maximum door opening force of 5 pounds (see CBC 1133B.2.5.1 and ADAAG 4.13.11).

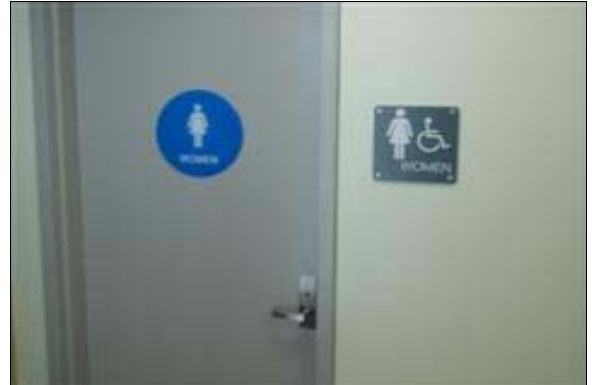
Womens Restroom at Rear of Stage

Finding: There is signage indicating accessibility on the entry door to the restroom. The signage is centered 60 inches above the floor on the latch side of the entrance door and includes Braille and raised lettering, gender use symbol and the ISA symbol.

Full Rec The restroom is designated accessible and should be made an accessible restroom for the facility. Monitor signage for continued compliance with CBC 1115B.5, ADAAG 4.1.2(7) and ADAAG 4.1.6(3)(e) and ADAAG 4.30.

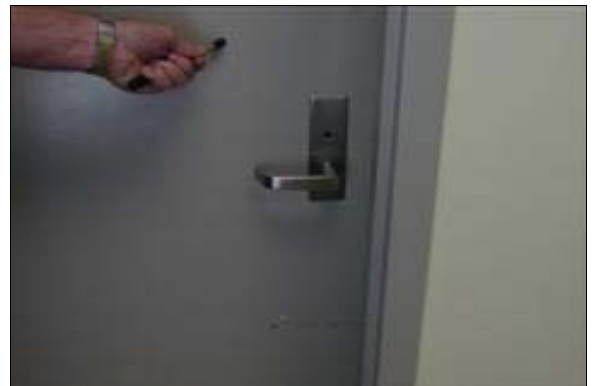
Womens Restroom at Rear of Stage

Finding: The door opening force for the interior entrance door to the restroom is greater than 5 pounds.

Full Rec Adjust the closer on the interior entrance door to the restroom to a maximum door opening force of 5 pounds (see CBC 1133B.2.5.1 and ADAAG 4.13.11).

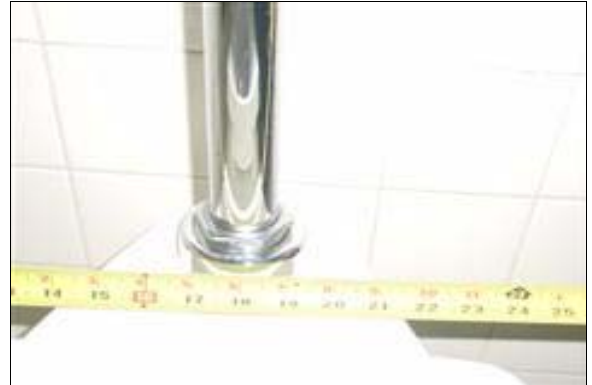
Womens Restroom at Rear of Stage

Finding: The distance from the center of the toilet to the nearest side wall in the restroom is 17 3/4 inches.

Full Rec Relocate the toilet so that the distance from the centerline of the toilet to the nearest side wall in the restroom is exactly 18 inches (see ADAAG Figure 28).

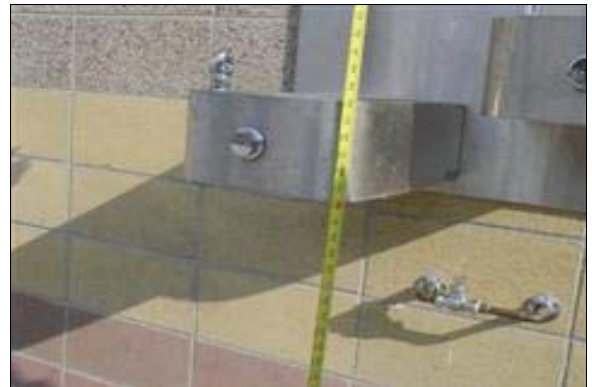
Drinking Fountain Outside Field House Restrooms

Finding: The spout outlet height is greater than 36 inches.

Full Rec Fifty percent of the drinking fountains on primary paths of travel shall be accessible. Install a "high-low" fountain design to comply with both state and federal requirements and install a side rail or wing wall next to each side of the fountain. Provide at least 30 inches in width and 48 inches in depth in front of the drinking fountain. The height of the spout outlet shall not exceed 36 inches in height. Fountain controls shall be accessible. The spout shall direct the water flow at least 4 inches high and in a trajectory that is parallel or nearly parallel to the front of the drinking fountain. Wall-mounted drinking fountains shall provide a minimum knee clearance height of 27 inches, 30 inches in width and between 18 inches and 19 inches in fountain depth.

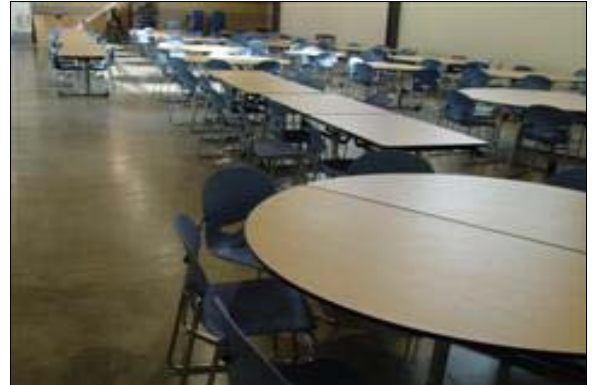
Cafeteria

Finding: There are no designated wheelchair seating spaces provided.

Full Rec Provide an ISA symbol designating at least 5% of each type of seating provided in the dining area as accessible. Accessible tables shall provide knee clearance of at least 27 inches in height, 30 inches in width and 19 inches in depth (see CBC 1122B.3, ADAAG 4.32.2 and ADAAG Figure 45). The table top height shall not exceed 34 inches above the finished floor. At least one companion fixed seat complying with ADAAG 4.33.3 should be provided next to each wheelchair seating space. An accessible route shall lead to and through each accessible seating area.

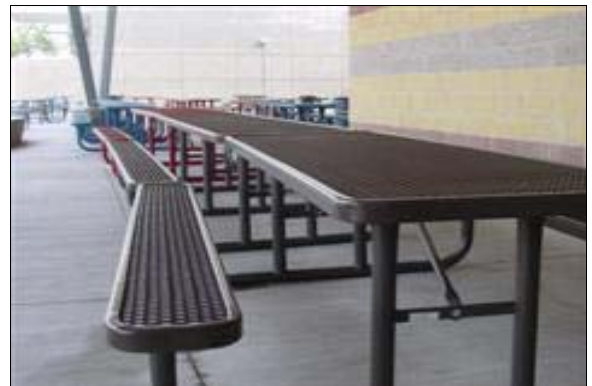
Outdoor Dining Area

Finding: There are no designated wheelchair seating spaces provided. The tables in the outdoor dining area are not accessible by design.

Full Rec Provide an ISA symbol designating at least 5% of each type of seating provided in the dining area as accessible. Accessible tables shall provide knee clearance of at least 27 inches in height, 30 inches in width and 19 inches in depth (see CBC 1122B.3, ADAAG 4.32.2 and ADAAG Figure 45). The table top height shall not exceed 34 inches above the finished floor. At least one companion fixed seat complying with ADAAG 4.33.3 should be provided next to each wheelchair seating space. An accessible route shall lead to and through each accessible seating area.

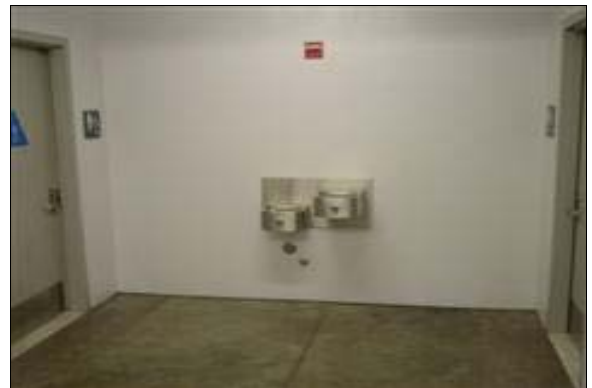
Finding: There are visual warning devices in the restrooms.

Full Rec Install visual warning devices integrated with the facility's alarm system complying with CBC 1114B.2.5, ADAAG 4.1.3(14) and ADAAG 4.28 throughout the facility.
