Site Survey of Selected Items  
for  
Compliance with the Americans with Disabilities Act  
(ADAAG)  
and  
Title 24 of the CBC

The site survey of Ellen Ochoa Learning Center was conducted on February 27, 2007 during a spot check for compliance with the Americans with Disabilities Act Guidelines (ADAAG) and Title 24 of the CBC

# Facility Name: Ellen Ochoa Learning Center

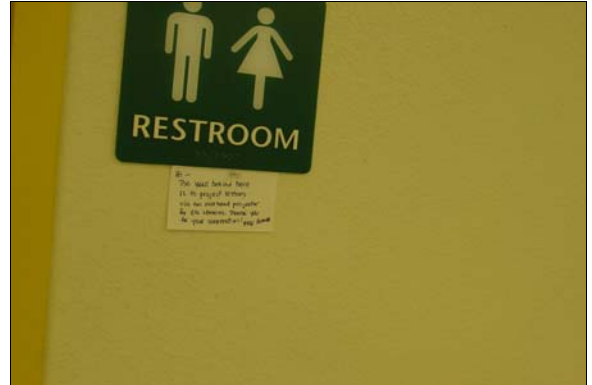
Staff Unisex Restroom in the Staff Lounge

**Finding:** There is signage on the latch side of the entry door of the restroom. The signage does not have raised pictograms or ISA symbol.

**Full Rec** Post signage centered 60 inches above the ground surface on the latch side of the entrance door identifying the restroom as accessible. Signage shall include Braille and raised lettering, the gender or unisex use symbol and the ISA symbol. Post Title 24 gender use signage on the door @ 60" o.c. a.f.f.

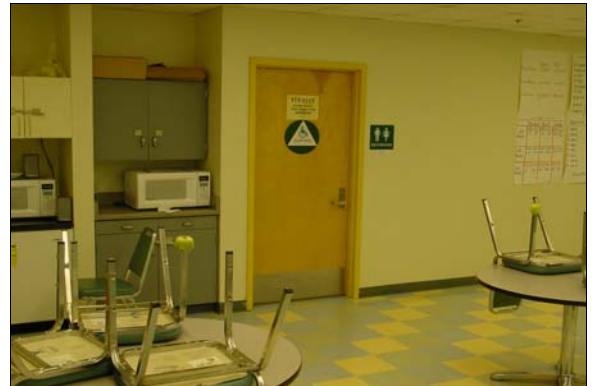
Staff Unisex Restroom in the Staff Lounge

**Finding:** The door opening force for the interior entrance door to the restroom is greater than 5 pounds.

**Full Rec** Adjust the closer on the interior entrance door to the restroom to a maximum door opening force of 5 pounds (see CBC 1133B.2.5.1 and ADAAG 4.13.11).

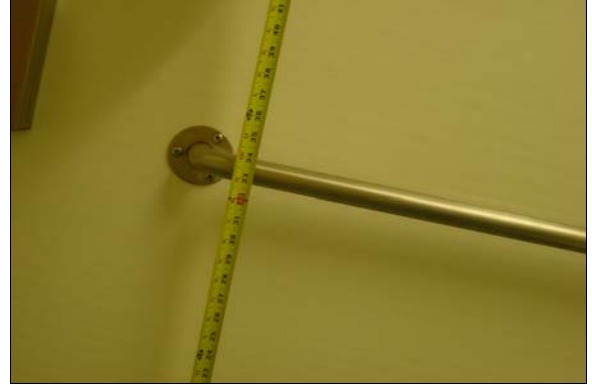
Staff Unisex Restroom in the Staff Lounge

**Finding:** The height of the side and back grab bar in the restroom is greater than 33 inches above the finished floor. The side grab bar does not extend 54 inches from the back wall.

**Full Rec** Remount the side and back grab bar in the restroom so that the height of the gripping surface is centered at 33 inches above the finished floor. The side grab bar must extend 54 inches from the back wall.

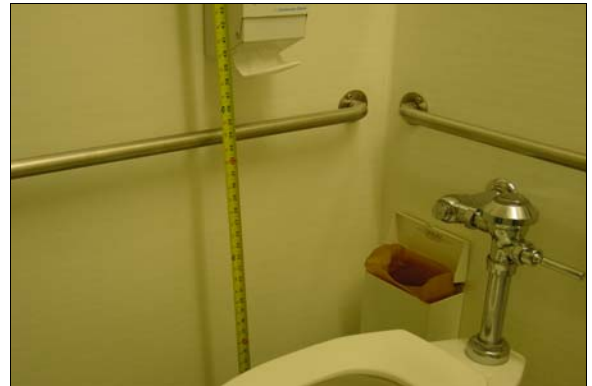
Staff Unisex Restroom in the Staff Lounge

**Finding:** The location of the toilet paper dispenser in the restroom is not within 12 inches of the front edge of the toilet and interferes with the use of the side grab bar.

**Full Rec** Remount the toilet paper dispenser so it is within 12 inches from the front edge of the toilet (see CBC 1115B.9.3 and ADAAG Figure 29(b)). Toilet paper dispensers must allow continuous paper flow and shall not interfere with the use of the side grab bar.

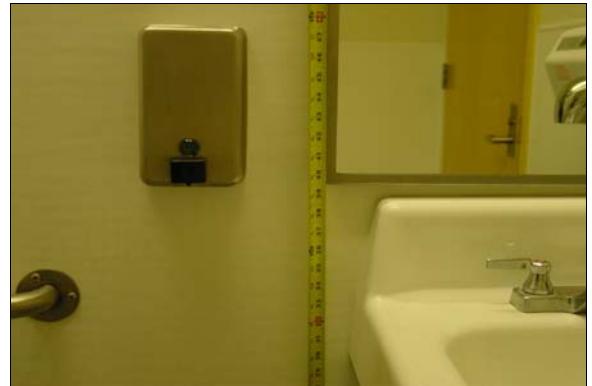
Staff Unisex Restroom in the Staff Lounge

**Finding:** The height of the controls and operating mechanisms for the soap dispenser is greater than 40 inches in height.

**Full Rec** Relocate the soap dispenser to a maximum height of 40 inches for all the controls and operating mechanisms (see CBC 1115B.9.2).

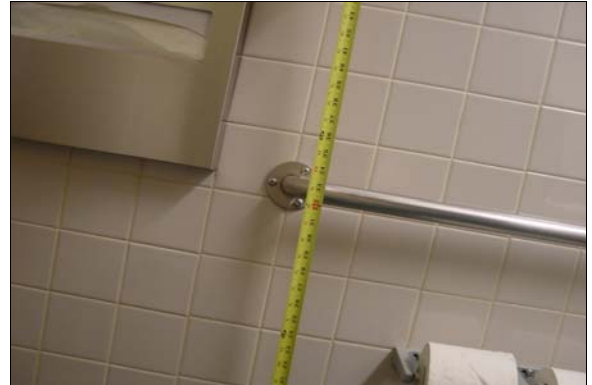
Staff Womens Restroom in the Main Office

**Finding:** The height of the side and back grab bar is less than 33 inches above the finished floor.

**Full Rec** Remount the side and back grab bar in the restroom so that the height of the gripping surface is centered at 33 inches above the finished floor. The side grab bar must extend at least 54 inches from the back wall.

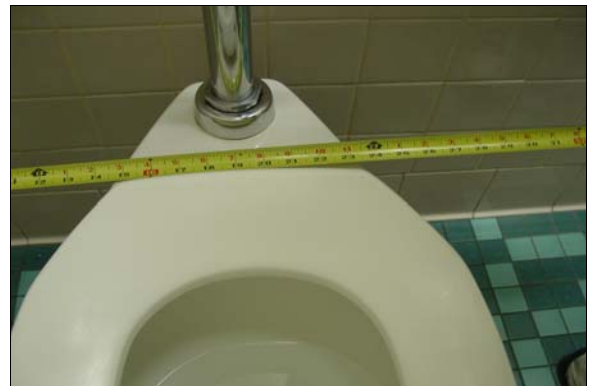
Staff Womens Restroom in the Main Office

**Finding:** The distance from the center of the toilet to the nearest side wall is greater than 18 inches.

**Full Rec** Relocate the toilet so that the distance from the centerline of the toilet to the nearest side wall is exactly 18 inches (see ADAAG Figure 28).

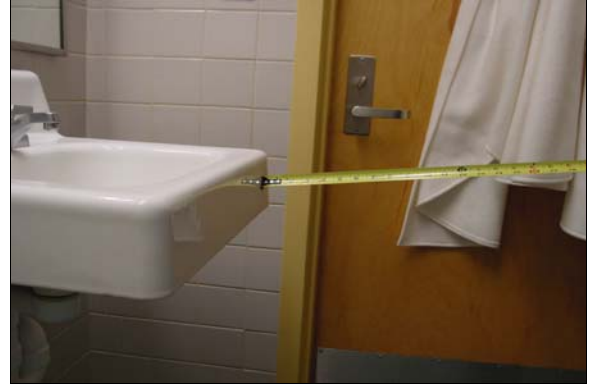
Staff Womens Restroom in the Main Office

**Finding:** There is less than 12 inches of clearance on the latch side of the entrance door to the restroom from the push side.

**Full Rec** Provide at least 12 inches of latch side clearance at the entrance door to the restroom from the push side (see ADAAG 4.13.6 and Figure 25). Otherwise, install an automatic door opening device to the primary entrance complying with ADAAG 4.13.12 and ANSI/BHMA A156.10, 1985, standards.

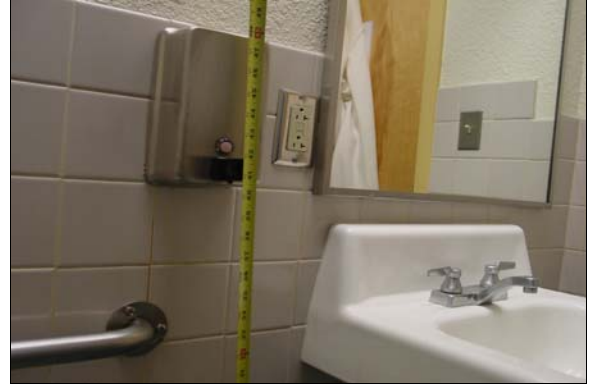
Staff Womens Restroom in the Main Office

**Finding:** The height of the controls and operating mechanisms for the soap dispenser is greater than 40 inches in height.

**Full Rec** Relocate the soap dispenser to a maximum height of 40 inches for all the controls and operating mechanisms (see CBC 1115B.9.2).

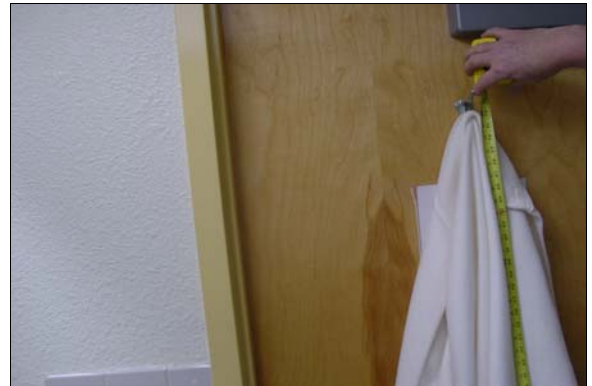
Staff Womens Restroom in the Main Office

**Finding:** The coat hook on the entrance door is mounted greater than 48 inches above the floor.

**Full Rec** Relocate the coat hook to a height no greater than 48 inches above the floor.

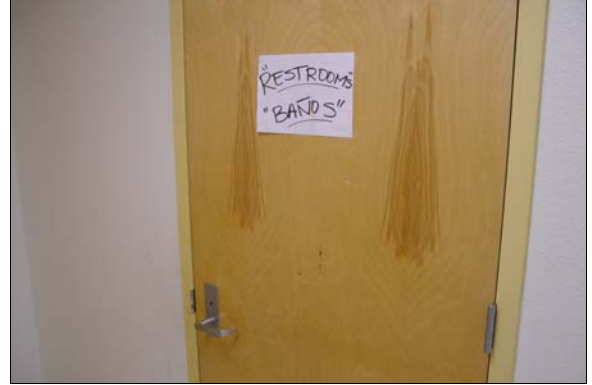
Unisex Restroom in the Nurses Office

**Finding:** There is no signage indicating accessibility on the latch side of the entry door of the restroom. There is no Title 24 gender use signage on the entrance door.

**Full Rec** Post signage centered 60 inches above the ground surface on the latch side of the entrance door identifying the restroom as accessible. Signage shall include Braille and raised lettering, the gender or unisex use symbol and the ISA symbol. Post Title 24 gender use signage on the door @ 60" o.c. a.f.f.

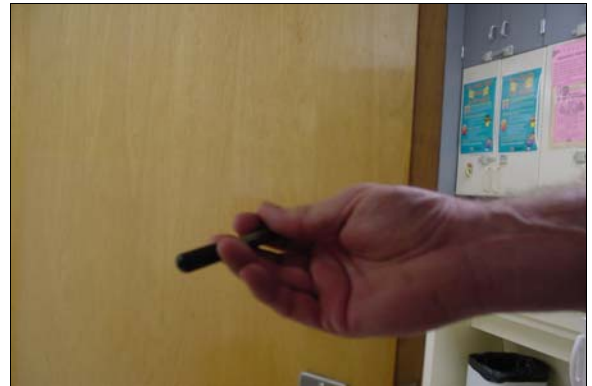
Unisex Restroom in the Nurses Office

**Finding:** The door opening force for the interior entrance door to the restroom is greater than 5 pounds.

**Full Rec** Adjust the closer on the interior entrance door to the restroom to a maximum door opening force of 5 pounds (see CBC 1133B.2.5.1 and ADAAG 4.13.11).

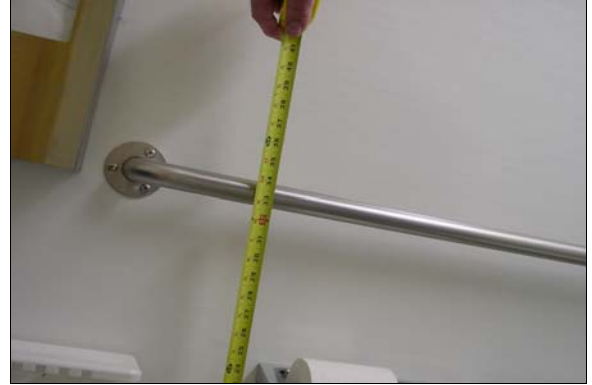
Unisex Restroom in the Nurses Office

**Finding:** The height of the side and back grab bar is greater than 33 inches above the finished floor.

**Full Rec** Remount the side and back grab bar so the height of the gripping surface is centered at 33 inches above finished floor. Grab bars must be able to support a point load of at least 250 pounds and shall be less than the allowable shear stress of the grab bar material.
