Site Survey of Selected Items
for
Compliance with the Americans with Disabilities Act
(ADAAG)
and
Title 24 of the CBC

The site survey of 32nd Street School was conducted on
February 27, 2007 during a spot check for compliance with the
Americans with Disabilities Act Guidelines (ADAAG)
and
Title 24 of the CBC

Facility Name: 32nd Street School

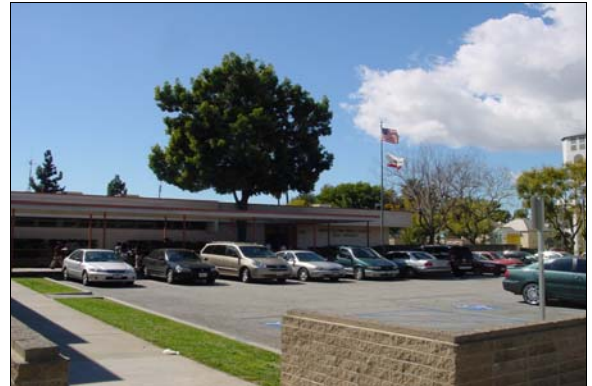
Finding: The 32nd Street School is located at 822 West 32nd Street Los Angeles California. The school provides services to students in grades K thru 8 and was inspected by Disability Access Consultants, Inc., on February 27, 2007. This is a report of selected items and is not intended as a full report.

Full Rec Any renovation or new construction that occurred after January 26, 1992, is subject to meet full code specifications for the California Building Code and ADAAG requirements. All recommendations in this report are based on ADAAG and CBC title 24 requirements. Consult with your design professional to determine which elements are affected by these requirements. It is recommended that Disability Access Consultants, Inc. is consulted for inspection of any new construction or renovation at the facility.
