Site Survey of Selected Items  
for  
Compliance with the Americans with Disabilities Act  
(ADAAG)  
and  
Title 24 of the CBC

The site survey of Ellen Ochoa Learning Center was conducted on February 27, 2007 during a spot check for compliance with the Americans with Disabilities Act Guidelines (ADAAG) and Title 24 of the CBC

# Facility Name: Ellen Ochoa Learning Center

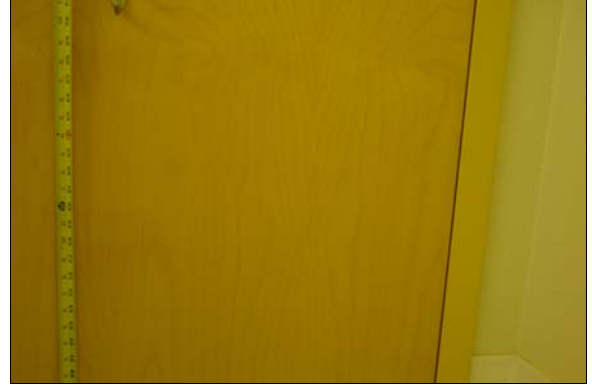
Staff Unisex Restroom in the Staff Lounge

**Finding:** The coat hook on the entrance door is mounted greater than 48 inches above the floor.

**Full Rec** Relocate the coat hook to a height no greater than 48 inches above the floor.

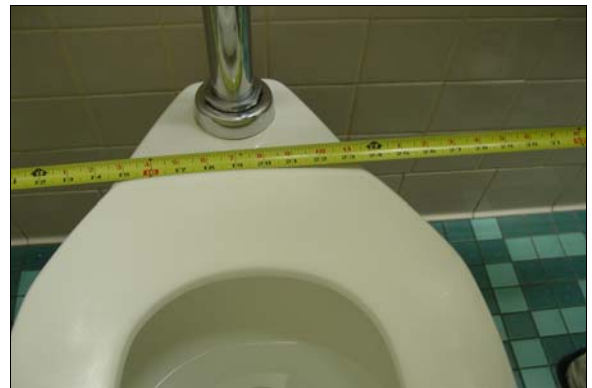
Staff Womens Restroom in the Main Office

**Finding:** The distance from the center of the toilet to the nearest side wall is greater than 18 inches.

**Full Rec** Relocate the toilet so that the distance from the centerline of the toilet to the nearest side wall is exactly 18 inches (see ADAAG Figure 28).

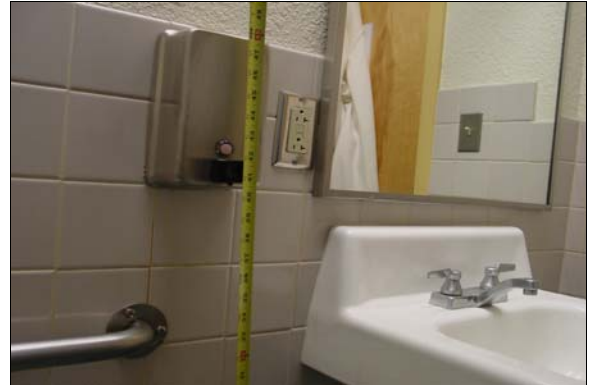
Staff Womens Restroom in the Main Office

**Finding:** The height of the controls and operating mechanisms for the soap dispenser is greater than 40 inches in height.

**Full Rec** Relocate the soap dispenser to a maximum height of 40 inches for all the controls and operating mechanisms (see CBC 1115B.9.2).

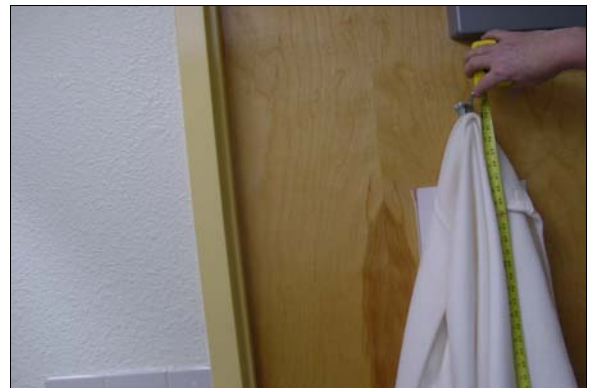
Staff Womens Restroom in the Main Office

**Finding:** The coat hook on the entrance door is mounted greater than 48 inches above the floor.

**Full Rec** Relocate the coat hook to a height no greater than 48 inches above the floor.
